General Information

Make	Toyota	Model	Vios
YOM	2025	Odo Meter Reading	16,425
Registration No.	NKG1777	Chassis No.	PA1B18F35R4270244
CC	1.3	Transmission	CVT
Fuel Type	Gas	Type of Body	Sedan
Colour	Blue

Body / Panel Condition

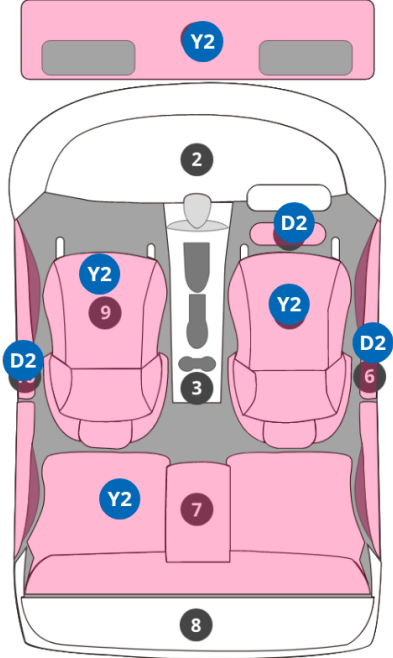
Interior Evaluation : B	Exterior Evaluation : C

<p>a : Cut, Fray d : Loose, Deformed k : Animal Hair s : Smell t : Cigarette Burns x : Defective y : Stain</p>

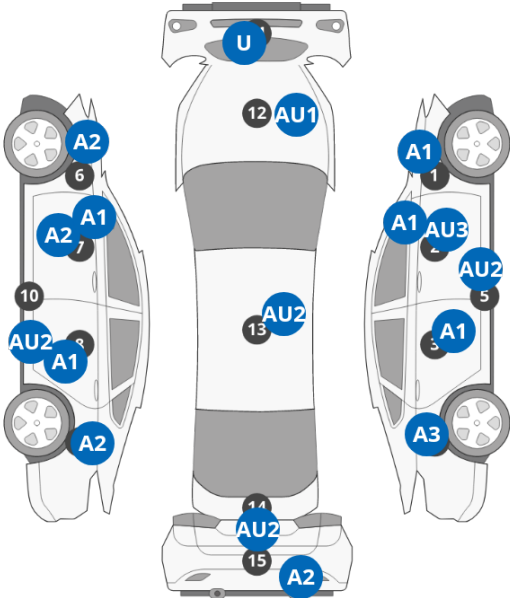
<p>A : Scratch AU : Scratch & Dent B : Modified C : Corrosion G : Stone chip P : Faded S : Rust SC : Rust & Corrosion U : Dent X : Defective Y : Crack, Gap</p>
<p>Remarks (L) Front Floor Mat - Worked - Small / (L) Front Trim - Worked - Small / (R) Front Trim - Worked - Small / Ceiling - Grime - Small / (L) Front Seat - Grime - Small / (R) Front Seat - Grime - Small / Rear Seat - Grime - Small</p>	<p>Remarks Member (Bolted) - Dent - Yes / (R) Front Door, Molding - Scratch & Dent - Medium / (R) Rear Door, Molding - Scratch - Minimal / (R) Step, In-panel, Side Spoiler - Scratch & Dent - Small / (R) Rear Fender, Molding - Scratch - Medium / Trunk Hood, Rear Gate - Scratch & Dent - Small / Rear Bumper, Lamps, Panels - Scratch - Small / (L) Rear Fender, Molding - Scratch - Small / (L) Rear Door, Molding - Scratch - Minimal / (L) Front Door, Molding - Scratch - Small / (L) Step, In-panel, Side Spoiler - Scratch & Dent - Small / (L) Front Fender, Molding - Scratch - Small / (L) Mirror - Scratch - Minimal / (R) Mirror - Scratch - Minimal / (R) Front Fender, Molding - Scratch - Minimal / Bonnet, Headlight - Scratch & Dent - Minimal / Roof - Scratch & Dent - Small</p>
