General Information

Make	Toyota	Model	Hiace
YOM	2020	Odo Meter Reading	63,747
Registration No.	DAZ5731	Chassis No.	JTFJ02P4K5022988
CC	3.0	Transmission	M/T
Fuel Type	Diesel	Type of Body	Van
Colour	White

Body / Panel Condition

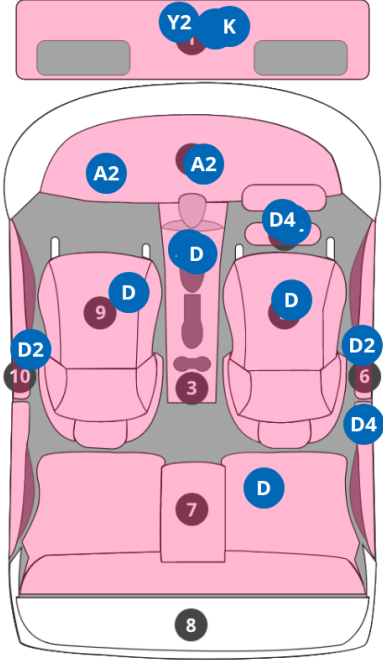
Interior Evaluation : E	Exterior Evaluation : E

<p>a : Cut, Fray d : Loose, Deformed k : Animal Hair s : Smell t : Cigarette Burns x : Defective y : Stain</p>

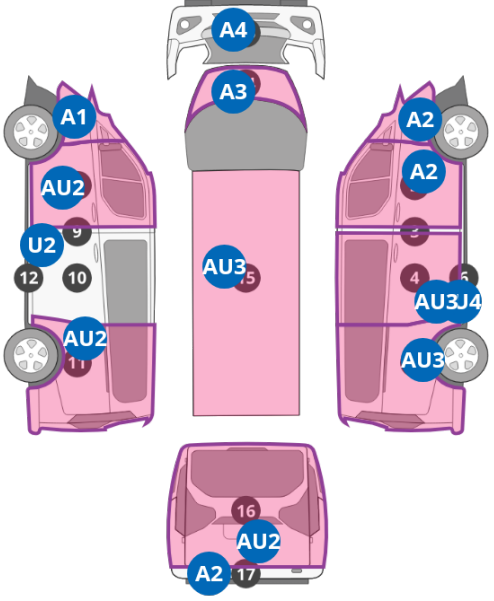
<p>A : Scratch AU : Scratch & Dent B : Modified C : Corrosion G : Stone chip P : Faded S : Rust SC : Rust & Corrosion U : Dent X : Defective Y : Crack, Gap</p>
<p>Remarks Mat Other - Worked - Small / (R) Rear Trim - Worked - Large / Ceiling - Grime - Small / Overall Interior - Smell - Yes / Overall Interior - Animal Hair - Yes / Dashboard - Worn, Scratch, Cut, Crack - Small / (R) Front Trim - Worked - Small / (L) Front Trim - Worked - Small / (L) Front Seat - Worn - Yes / (R) Front Seat - Worn - Yes / Rear Seat - Worn - Yes / (L) Front Floor Mat - Worked - Large / Steering Wheel - Worn, Peel, Crack - Small / Console, Switches, Vents - Worn, Scratch, Cut, Crack - Small / Console, Switches, Vents - Traces of Adhesive Tape - Yes</p>	<p>Remarks (R) Front Door - Repair Traces - Yes / (R) Step - Repair Traces - Yes / (R) Front Fender - Repair Traces - Yes / Bonnet - Repair Traces - Yes / (L) Front Fender - Repair Traces - Yes / (L) Front Door - Repair Traces - Yes / (L) Step - Repair Traces - Yes / (L) Rear Fender - Repair Traces - Yes / Trunk Hood, Rear Gate - Repair Traces - Yes / (R) Rear Fender - Repair Traces - Yes / (R) Rear Fender - Replaced - Yes / (R) Rear Door - Repair Traces - Yes / Roof - Repair Traces - Yes / Roof - Replaced - Yes / (L) Front Fender, Molding - Repair mark - Yes / Bonnet, Headlight - Repair mark - Yes / (R) Front Fender, Molding - Repair mark - Yes / (R) Front Door, Molding - Repair mark - Yes / (R) Rear Door, Molding - Repair mark - Yes / (L) Rear Fender, Molding - Repair mark - Yes / Trunk Hood, Rear Gate - Repair mark - Yes / (L) Front Door, Molding - Repair mark - Yes / (L) Step, In-panel, Side Spoiler - Dent - Small / (L) Front Door, Molding - Scratch & Dent - Small / (L) Rear Fender, Molding - Scratch & Dent - Small / (L) Front Fender, Molding - Scratch - Minimal / Bonnet, Headlight - Scratch - Medium / Front Bumper, Grille, Lamps - Scratch - Large / (R) Front Fender, Molding - Scratch - Small / (R) Front Door, Molding - Scratch - Small / (R) Step, In-panel, Side Spoiler - Scratch & Dent - Large / (R) Rear Door, Molding - Scratch & Dent - Medium / (R) Rear Fender, Molding - Scratch & Dent - Medium / Trunk Hood, Rear Gate - Scratch & Dent - Small / Rear Bumper, Lamps, Panels - Scratch - Small / Roof - Scratch & Dent - Medium</p>
