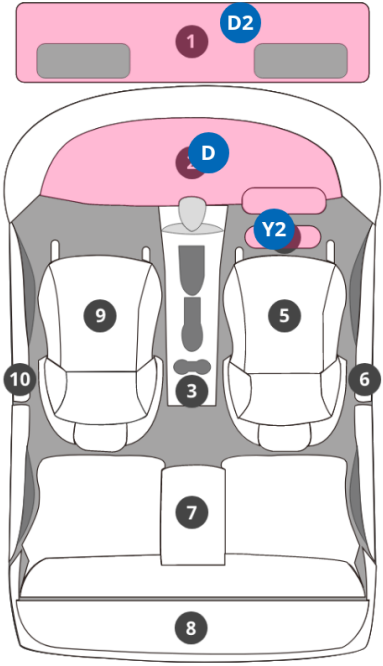
Interior Evaluation : A	Exterior Evaluation : D

<p>a : Cut, Fray d : Loose, Deformed k : Animal Hair s : Smell t : Cigarette Burns x : Defective y : Stain</p>

<p>A : Scratch AU : Scratch & Dent B : Modified C : Corrosion G : Stone chip P : Faded S : Rust SC : Rust & Corrosion U : Dent X : Defective Y : Crack, Gap</p>
<p>Remarks (L) Front Floor Mat - Grime - Small / Dashboard - Traces of Adhesive Tape - Yes / Ceiling - Crinkle - Small</p>	<p>Remarks (L) Front Fender, Molding - Scratch - Small / (R) Front Door, Molding - Scratch - Small / (R) Front Fender, Molding - Scratch - Minimal / (R) Mirror - Scratch - Minimal / (R) Side Gate - Scratch & Dent - Small / (L) Side Gate - Scratch & Dent - Small / (L) Front Door, Molding - Scratch - Small / (L) Mirror - Scratch - Minimal / Front Bumper, Grille, Lamps - Scratch - Small / Bonnet, Headlight - Scratch & Dent - Small / Roof - Scratch & Dent - Small / (L) Step, In-panel, Side Spoiler - Scratch & Dent - Small / (R) Step, In-panel, Side Spoiler - Scratch & Dent - Small / Rear Bumper, Lamps, Panels - Scratch - Small / Cargo Bed Floor - Scratch - Large / Cab Back Panel - Scratch - Medium</p>
