## General Information

<b>Make</b>	Toyota	<b>Model</b>	Wigo
<b>YOM</b>	2025	<b>Odo Meter Reading</b>	24,585
<b>Registration No.</b>	CCG4652	<b>Chassis No.</b>	MHKAA1BC9RJ024809
<b>CC</b>	1.0	<b>Transmission</b>	CVT
<b>Fuel Type</b>	Gas	<b>Type of Body</b>	Hatchback
<b>Colour</b>	Gray

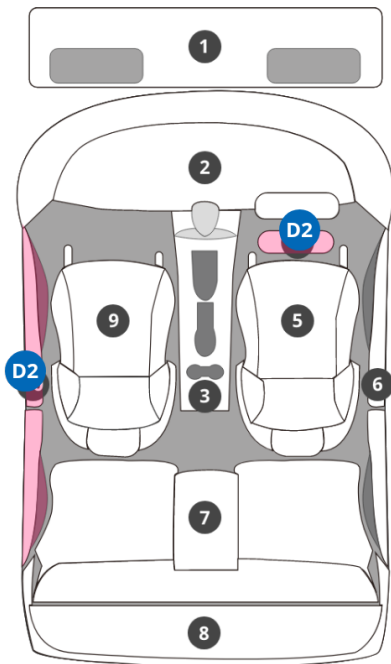
<b>Interior Evaluation :</b> <span style="color: red; font-size: 1.5em; font-weight: bold;">A</span>	<b>Exterior Evaluation :</b> <span style="color: red; font-size: 1.5em; font-weight: bold;">C</span>

<p><b>a</b> : Cut, Fray <b>d</b> : Loose, Deformed <b>k</b> : Animal Hair <b>s</b> : Smell <b>t</b> : Cigarette Burns <b>x</b> : Defective <b>y</b> : Stain</p>

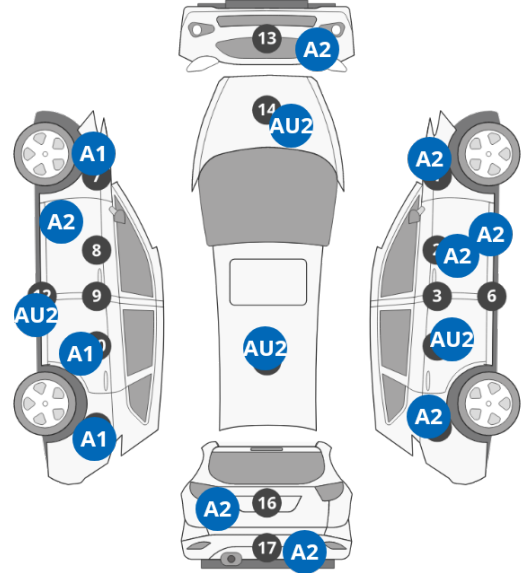
<p><b>A</b> : Scratch <b>AU</b> : Scratch &amp; Dent <b>B</b> : Modified <b>C</b> : Corrosion <b>G</b> : Stone chip <b>P</b> : Faded <b>S</b> : Rust <b>SC</b> : Rust &amp; Corrosion <b>U</b> : Dent <b>X</b> : Defective <b>Y</b> : Crack, Gap</p>
<p><b>Remarks</b> (L) Front Floor Mat - Worked - Small / (L) Front Trim - Worked - Small</p>	<p><b>Remarks</b> Trunk Hood, Rear Gate - Scratch - Small / (L) Rear Fender, Molding - Scratch - Minimal / (L) Rear Door, Molding - Scratch - Minimal / (L) Front Door, Molding - Scratch - Small / (L) Step, In-panel, Side Spoiler - Scratch &amp; Dent - Small / (L) Front Fender, Molding - Scratch - Minimal / Front Bumper, Grille, Lamps - Scratch - Small / Bonnet, Headlight - Scratch &amp; Dent - Small / (R) Front Fender, Molding - Scratch - Small / (R) Front Door, Molding - Scratch - Small / (R) Rear Door, Molding - Scratch &amp; Dent - Small / (R) Rear Fender, Molding - Scratch - Small / Roof - Scratch &amp; Dent - Small / Rear Bumper, Lamps, Panels - Scratch - Small / (R) Step, In-panel, Side Spoiler - Scratch - Small</p>

<p><b>Inspector Notes</b></p>
<p>With LTO plate and Sparetire and Jack and Incomplete Tools, No warranty booklet, scratch headlight and tail light.</p>
