General Information

Make	Toyota	Model	Innova
YOM	2025	Odo Meter Reading	18,677
Registration No.	NKI3100	Chassis No.	PA2JA8EM2R0145422
CC	2.8	Transmission	A/T
Fuel Type	Diesel	Type of Body	Wagon
Colour	Blackish Red Mica

Body / Panel Condition

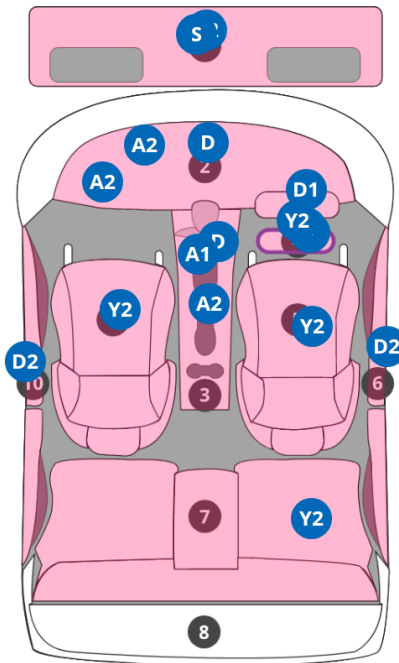
Interior Evaluation : B	Exterior Evaluation : D

<p>a : Cut, Fray d : Loose, Deformed k : Animal Hair s : Smell t : Cigarette Burns x : Defective y : Stain</p>

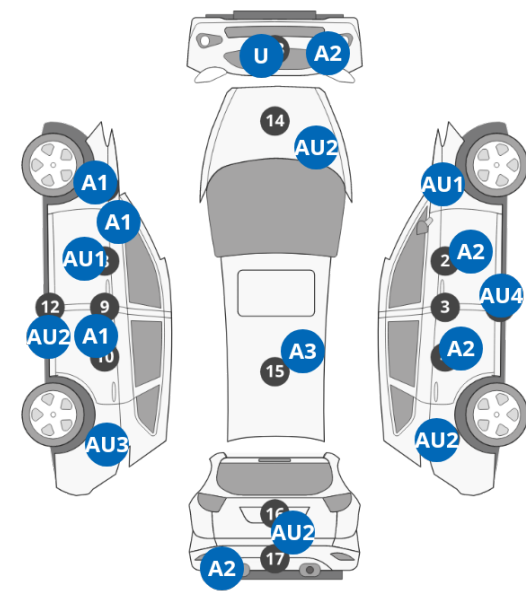
<p>A : Scratch AU : Scratch & Dent B : Modified C : Corrosion G : Stone chip P : Faded S : Rust SC : Rust & Corrosion U : Dent X : Defective Y : Crack, Gap</p>
<p>Remarks (L) Front Trim - Worked - Small / (R) Front Trim - Worked - Small / (L) Front Floor Mat - Missing - Yes / (R) Front Floor Mat - Missing - Yes / Mat Other - Grime - Small / Rear Seat - Grime - Small / (R) Front Seat - Grime - Small / (L) Front Seat - Grime - Small / Console, Switches, Vents - Traces of Adhesive Tape - Yes / Dashboard - Traces of Adhesive Tape - Yes / Ceiling - Grime - Small</p>	<p>Remarks Member (Bolted) - Dent - Yes / (L) Front Fender, Molding - Scratch - Minimal / (L) Front Door, Molding - Scratch & Dent - Minimal / (L) Rear Door, Molding - Scratch - Minimal / (L) Step, In-panel, Side Spoiler - Scratch & Dent - Small / (L) Mirror - Scratch - Minimal / Rear Bumper, Lamps, Panels - Scratch - Small / Trunk Hood, Rear Gate - Scratch & Dent - Small / (L) Rear Fender, Molding - Scratch & Dent - Medium / (R) Rear Fender, Molding - Scratch & Dent - Small / (R) Rear Door, Molding - Scratch - Small / (R) Step, In-panel, Side Spoiler - Scratch & Dent - Large / (R) Front Door, Molding - Scratch - Small / (R) Front Fender, Molding - Scratch & Dent - Minimal / Front Bumper, Grille, Lamps - Scratch - Small / Bonnet, Headlight - Scratch & Dent - Small / Roof - Scratch - Medium</p>
