General Information

Make	Toyota	Model	Avanza
YOM	2020	Odo Meter Reading	72,276
Registration No.	CAV2383	Chassis No.	MHKM5EF2FLK024368
CC	1.3	Transmission	A/T
Fuel Type	Gas	Type of Body	Wagon
Colour	Black

Body / Panel Condition

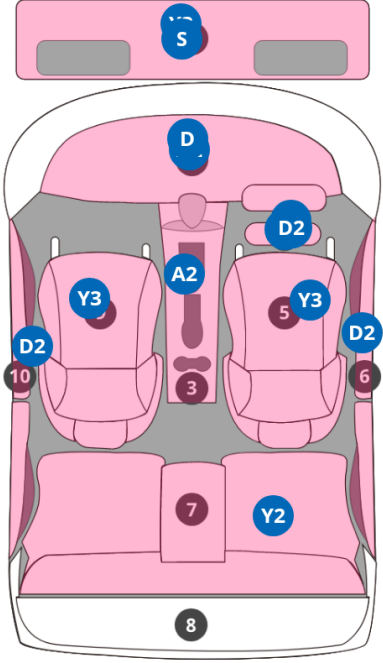
Interior Evaluation : C	Exterior Evaluation : D

<p>a : Cut, Fray d : Loose, Deformed k : Animal Hair s : Smell t : Cigarette Burns x : Defective y : Stain</p>

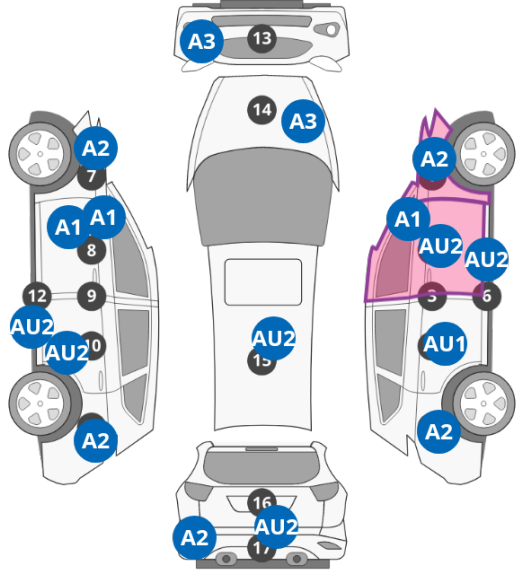
<p>A : Scratch AU : Scratch & Dent B : Modified C : Corrosion G : Stone chip P : Faded S : Rust SC : Rust & Corrosion U : Dent X : Defective Y : Crack, Gap</p>
Remarks (L) Front Seat - Grime - Medium / (R) Front Seat - Grime - Medium / (L) Front Trim - Worked - Small / (R) Front Trim - Worked - Small / Dashboard - Worn, Scratch, Cut, Crack - Small / Dashboard - Traces of Adhesive Tape - Yes / Ceiling - Grime - Medium / Overall Interior - Smell - Yes / Console, Switches, Vents - Worn, Scratch, Cut, Crack - Small / Rear Seat - Grime - Small / (L) Front Floor Mat - Worked - Small / (R) Front Floor Mat - Worked - Small / Mat Other - Worked - Small	Remarks (R) Front Door - Repair Traces - Yes / (R) Front Fender - Repair Traces - Yes / Bonnet, Headlight - Scratch - Medium / (R) Front Fender, Molding - Repair mark - Yes / (R) Front Door, Molding - Repair mark - Yes / Front Bumper, Grille, Lamps - Scratch - Medium / (L) Front Fender, Molding - Scratch - Small / (L) Front Door, Molding - Scratch - Minimal / (L) Rear Door, Molding - Scratch & Dent - Small / (L) Rear Fender, Molding - Scratch - Small / (L) Step, In-panel, Side Spoiler - Scratch & Dent - Small / (L) Mirror - Scratch - Minimal / Rear Bumper, Lamps, Panels - Scratch - Small / Trunk Hood, Rear Gate - Scratch & Dent - Small / (R) Rear Fender, Molding - Scratch - Small / (R) Rear Door, Molding - Scratch & Dent - Minimal / (R) Front Door, Molding - Scratch & Dent - Small / (R) Front Fender, Molding - Scratch - Small / Roof - Scratch & Dent - Small / (R) Mirror - Scratch - Minimal / (R) Step, In-panel, Side Spoiler - Scratch & Dent - Small
