General Information

Make	Toyota	Model	Avanza
YOM	2020	Odo Meter Reading	75,822
Registration No.	CAV2380	Chassis No.	MHKM5EF2FLK024411
CC	1.3	Transmission	A/T
Fuel Type	Gas	Type of Body	Wagon
Colour	Gray

Body / Panel Condition

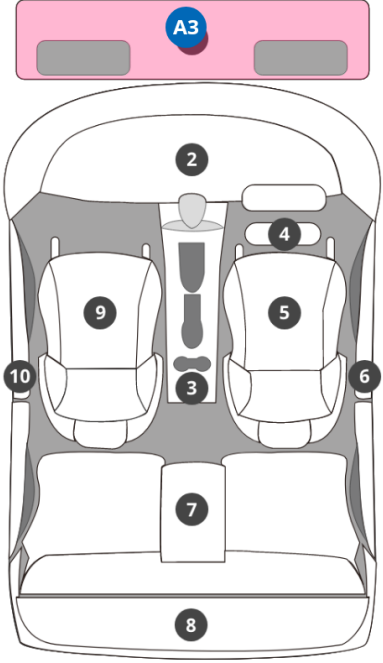
Interior Evaluation : B	Exterior Evaluation : D

<p>a : Cut, Fray d : Loose, Deformed k : Animal Hair s : Smell t : Cigarette Burns x : Defective y : Stain</p>

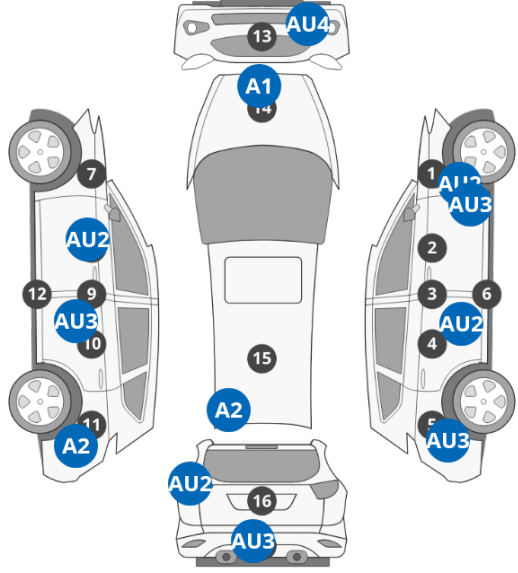
<p>A : Scratch AU : Scratch & Dent B : Modified C : Corrosion G : Stone chip P : Faded S : Rust SC : Rust & Corrosion U : Dent X : Defective Y : Crack, Gap</p>
Remarks Ceiling - Cut, Crack - Medium	Remarks (R) Front Fender, Molding - Scratch & Dent - Small / (R) Front Door, Molding - Scratch & Dent - Medium / (R) Rear Door, Molding - Scratch & Dent - Small / (R) Rear Fender, Molding - Scratch & Dent - Medium / Rear Bumper, Lamps, Panels - Scratch & Dent - Medium / Trunk Hood, Rear Gate - Scratch & Dent - Small / Roof - Scratch - Small / (L) Rear Fender, Molding - Scratch - Small / (L) Rear Door, Molding - Scratch & Dent - Medium / (L) Front Door, Molding - Scratch & Dent - Small / Front Bumper, Grille, Lamps - Scratch & Dent - Large / Bonnet, Headlight - Scratch - Minimal
