General Information

Make	Toyota	Model	Vios
YOM	2024	Odo Meter Reading	21,978
Registration No.	BAF8530	Chassis No.	PA1B18F31R4243400
CC	1.3	Transmission	CVT
Fuel Type	Gas	Type of Body	Sedan
Colour	Red

Body / Panel Condition

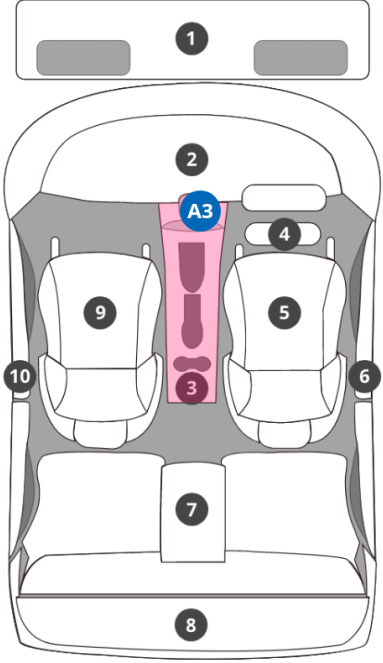
Interior Evaluation : B	Exterior Evaluation : B

<p>a : Cut, Fray d : Loose, Deformed k : Animal Hair s : Smell t : Cigarette Burns x : Defective y : Stain</p>

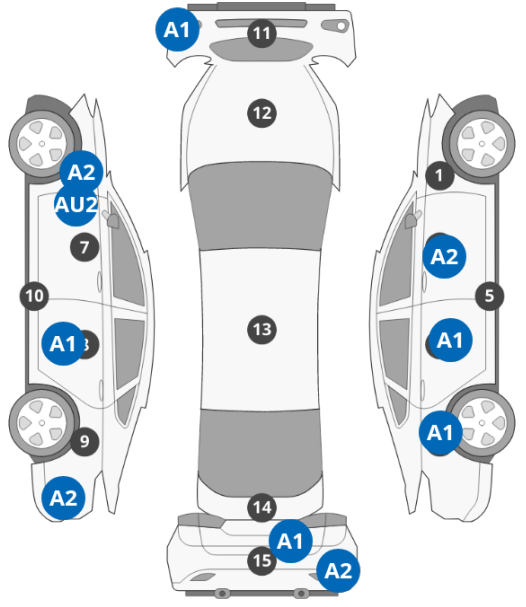
<p>A : Scratch AU : Scratch & Dent B : Modified C : Corrosion G : Stone chip P : Faded S : Rust SC : Rust & Corrosion U : Dent X : Defective Y : Crack, Gap</p>
Remarks Knobs - Worn, Peel, Crack - Medium	Remarks (R) Front Door, Molding - Scratch - Small / (R) Rear Door, Molding - Scratch - Minimal / (R) Rear Fender, Molding - Scratch - Minimal / Rear Bumper, Lamps, Panels - Scratch - Small / Trunk Hood, Rear Gate - Scratch - Minimal / (L) Rear Fender, Molding - Scratch - Small / (L) Rear Door, Molding - Scratch - Minimal / (L) Front Door, Molding - Scratch & Dent - Small / (L) Front Fender, Molding - Scratch - Small / Front Bumper, Grille, Lamps - Scratch - Minimal
Frame Evaluation : A	Functional Evaluation : B
Remarks Defects not found	Remarks Battery - Weak - Yes

Inspector Notes
With Lto plate, with jack, 2keys, no warranty booklet, no spare tire and tools, scratches on headlight and taillight
