## General Information

<b>Make</b>	Toyota	<b>Model</b>	Vios
<b>YOM</b>	2022	<b>Odo Meter Reading</b>	66,438
<b>Registration No.</b>	NFO1922	<b>Chassis No.</b>	PA1B18F33N4188457
<b>CC</b>	1.3	<b>Transmission</b>	CVT
<b>Fuel Type</b>	Gas	<b>Type of Body</b>	Sedan
<b>Colour</b>	Black

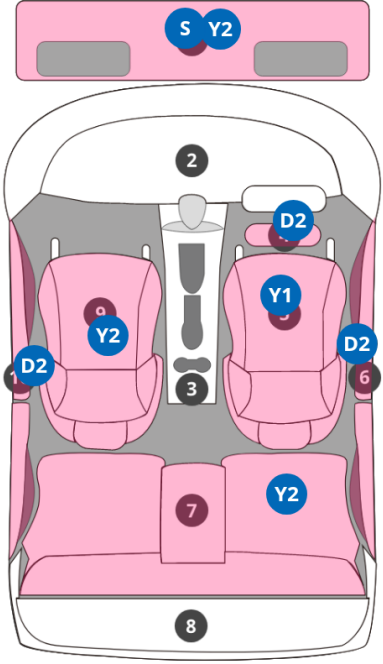
<b>Interior Evaluation :</b> <span style="float: right;"><b>B</b></span>	<b>Exterior Evaluation :</b> <span style="float: right;"><b>E</b></span>

<p><b>a</b> : Cut, Fray <b>d</b> : Loose, Deformed <b>k</b> : Animal Hair <b>s</b> : Smell <b>t</b> : Cigarette Burns <b>x</b> : Defective <b>y</b> : Stain</p>

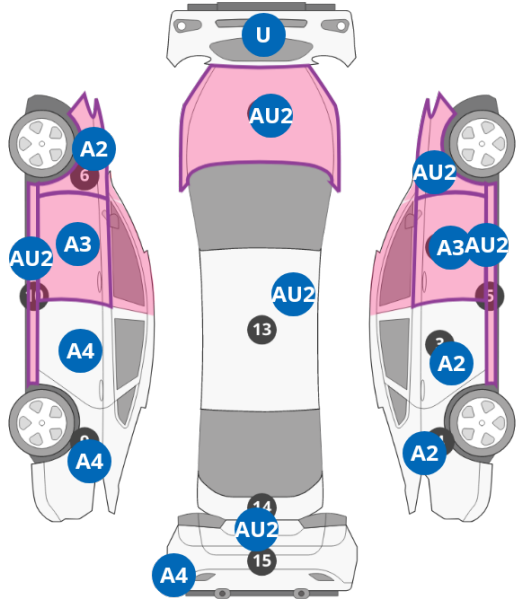
<p><b>A</b> : Scratch <b>AU</b> : Scratch &amp; Dent <b>B</b> : Modified <b>C</b> : Corrosion <b>G</b> : Stone chip <b>P</b> : Faded <b>S</b> : Rust <b>SC</b> : Rust &amp; Corrosion <b>U</b> : Dent <b>X</b> : Defective <b>Y</b> : Crack, Gap</p>
<p><b>Remarks</b> (L) Front Floor Mat - Worked - Small / (L) Front Trim - Worked - Small / (R) Front Trim - Worked - Small / Rear Seat - Grime - Small / (L) Front Seat - Grime - Small / (R) Front Seat - Grime - Minimal / Ceiling - Grime - Small / Overall Interior - Smell - Yes</p>	<p><b>Remarks</b> (R) Front Door - Repair Traces - Yes / (R) Step - Repair Traces - Yes / (R) Front Fender - Repair Traces - Yes / Bonnet - Repair Traces - Yes / (L) Front Fender - Repair Traces - Yes / (L) Front Door - Repair Traces - Yes / (L) Step - Repair Traces - Yes / Member (Bolted) - Dent - Yes / (L) Front Fender, Molding - Repair mark - Yes / (L) Step, In-panel, Side Spoiler - Repair mark - Yes / (L) Front Door, Molding - Repair mark - Yes / (R) Front Fender, Molding - Repair mark - Yes / Bonnet, Headlight - Repair mark - Yes / (R) Front Door, Molding - Repair mark - Yes / (R) Step, In-panel, Side Spoiler - Repair mark - Yes / (L) Front Fender, Molding - Scratch - Small / (L) Front Door, Molding - Scratch - Medium / (L) Rear Door, Molding - Scratch - Large / (L) Rear Fender, Molding - Scratch - Large / Rear Bumper, Lamps, Panels - Scratch - Large / Trunk Hood, Rear Gate - Scratch &amp; Dent - Small / (R) Rear Fender, Molding - Scratch - Small / (R) Rear Door, Molding - Scratch - Small / (R) Front Door, Molding - Scratch - Medium / (R) Step, In-panel, Side Spoiler - Scratch &amp; Dent - Small / (R) Front Fender, Molding - Scratch &amp; Dent - Small / Bonnet, Headlight - Scratch &amp; Dent - Small / Roof - Scratch &amp; Dent - Small / (L) Step, In-panel, Side Spoiler - Scratch &amp; Dent - Small</p>
