General Information

Make	Suzuki	Model	S-Presso
YOM	2022	Odo Meter Reading	37,808
Registration No.	FAI7741	Chassis No.	MA3FL41S6NA276528
CC	1.0	Transmission	M/T
Fuel Type	Gas	Type of Body	Hatchback
Colour	Silver

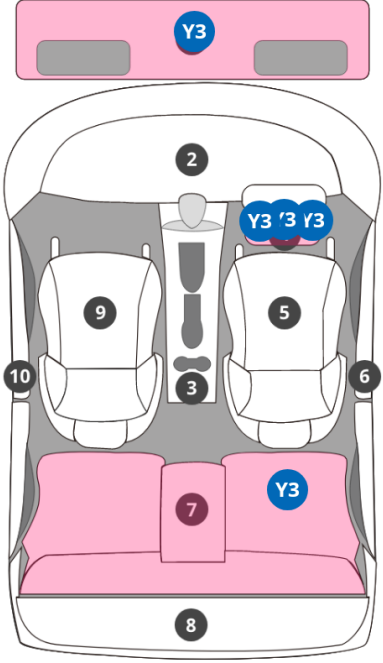
Interior Evaluation : C	Exterior Evaluation : C

<p>a : Cut, Fray d : Loose, Deformed k : Animal Hair s : Smell t : Cigarette Burns x : Defective y : Stain</p>

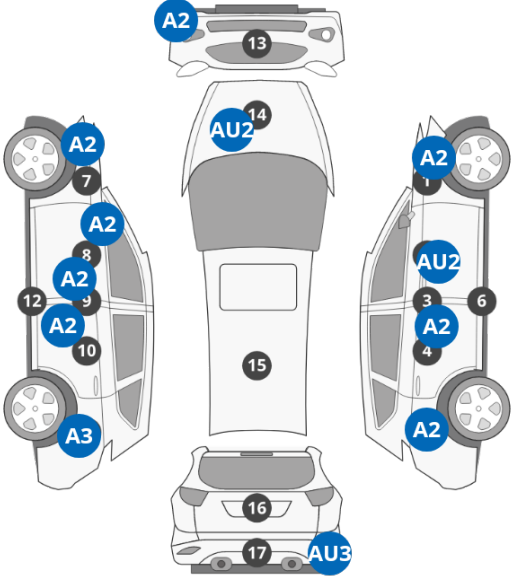
<p>A : Scratch AU : Scratch & Dent B : Modified C : Corrosion G : Stone chip P : Faded S : Rust SC : Rust & Corrosion U : Dent X : Defective Y : Crack, Gap</p>
<p>Remarks Ceiling - Grime - Medium / (R) Front Floor Mat - Grime - Medium / Rear Seat - Grime - Medium / Mat Other - Grime - Medium / (L) Front Floor Mat - Grime - Medium</p>	<p>Remarks (R) Front Door, Molding - Scratch & Dent - Small / (R) Front Fender, Molding - Scratch - Small / (R) Rear Door, Molding - Scratch - Small / (R) Rear Fender, Molding - Scratch - Small / (L) Rear Fender, Molding - Scratch - Medium / Rear Bumper, Lamps, Panels - Scratch & Dent - Medium / (L) Rear Door, Molding - Scratch - Small / (L) Front Door, Molding - Scratch - Small / (L) Mirror - Scratch - Small / (L) Front Fender, Molding - Scratch - Small / Bonnet, Headlight - Scratch & Dent - Small / Front Bumper, Grille, Lamps - Scratch - Small</p>
