General Information

Make	Toyota	Model	Vios
YOM	2022	Odo Meter Reading	39,792
Registration No.	NER7553	Chassis No.	PA1B18F37M4168324
CC	1.3	Transmission	CVT
Fuel Type	Gas	Type of Body	Sedan
Colour	Green

Body / Panel Condition

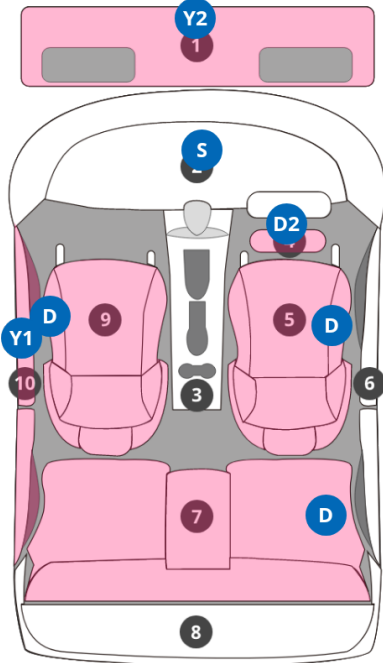
Interior Evaluation : B	Exterior Evaluation : E

<p>a : Cut, Fray d : Loose, Deformed k : Animal Hair s : Smell t : Cigarette Burns x : Defective y : Stain</p>

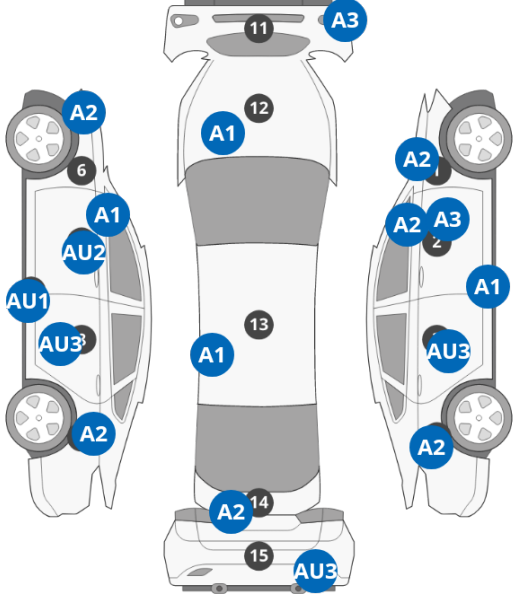
<p>A : Scratch AU : Scratch & Dent B : Modified C : Corrosion G : Stone chip P : Faded S : Rust SC : Rust & Corrosion U : Dent X : Defective Y : Crack, Gap</p>
<p>Remarks Overall Interior - Smell - Yes / (L) Front Floor Mat - Worked - Small / (L) Front Seat - Worn - Yes / Ceiling - Grime - Small / Rear Seat - Worn - Yes / (R) Front Seat - Worn - Yes / (L) Front Trim - Grime - Minimal</p>	<p>Remarks (R) Front Fender - Repair Traces - Yes / (R) Front Fender, Molding - Scratch - Small / (R) Mirror - Scratch - Small / (R) Front Door, Molding - Scratch - Medium / (R) Rear Door, Molding - Scratch & Dent - Medium / (R) Rear Fender, Molding - Scratch - Small / Trunk Hood, Rear Gate - Scratch - Small / (L) Rear Fender, Molding - Scratch - Small / (L) Mirror - Scratch - Minimal / (L) Front Fender, Molding - Scratch - Small / Front Bumper, Grille, Lamps - Scratch - Medium / Bonnet, Headlight - Scratch - Minimal / Roof - Scratch - Minimal / (L) Front Door, Molding - Scratch & Dent - Small / (R) Step, In-panel, Side Spoiler - Scratch - Minimal / Rear Bumper, Lamps, Panels - Scratch & Dent - Medium / (L) Step, In-panel, Side Spoiler - Scratch & Dent - Minimal / (L) Rear Door, Molding - Scratch & Dent - Medium</p>

<p>Inspector Notes</p>
<p>no warranty booklet, with jack, incomplete tools, with spare tire, no LTO plate, scratched and cracked tail light, possible flooding, head unit issue</p>
