General Information

Make	Toyota	Model	Vios
YOM	2020	Odo Meter Reading	82,598
Registration No.	DAZ1438	Chassis No.	PA1B18F35K4106224
CC	1.3	Transmission	CVT
Fuel Type	Gas	Type of Body	Sedan
Colour	Silver

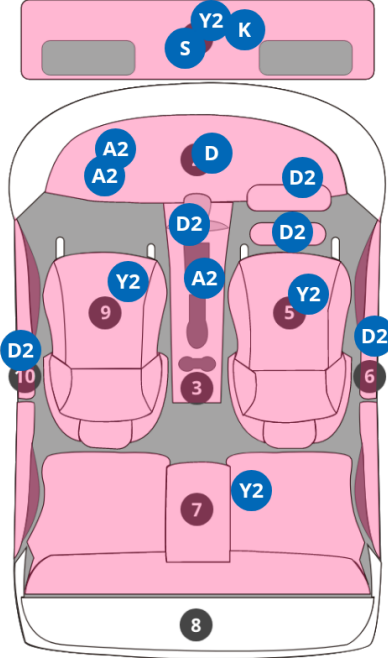
Interior Evaluation : C	Exterior Evaluation : E

<p>a : Cut, Fray d : Loose, Deformed k : Animal Hair s : Smell t : Cigarette Burns x : Defective y : Stain</p>

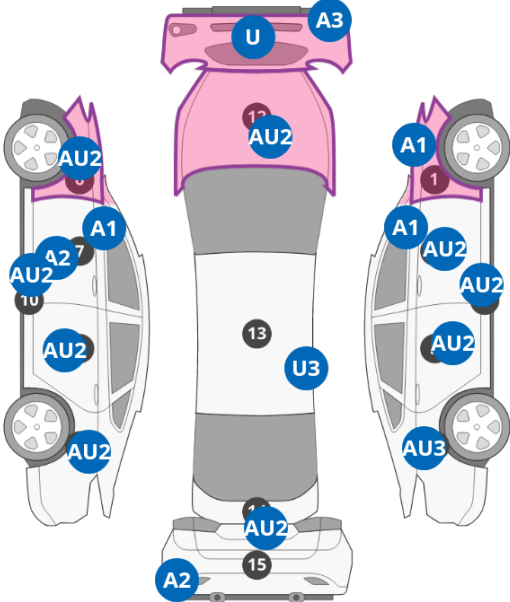
<p>A : Scratch AU : Scratch & Dent B : Modified C : Corrosion G : Stone chip P : Faded S : Rust SC : Rust & Corrosion U : Dent X : Defective Y : Crack, Gap</p>
<p>Remarks (L) Front Floor Mat - Worked - Small / (L) Front Trim - Worked - Small / (R) Front Trim - Worked - Small / Dashboard - Traces of Adhesive Tape - Yes / Ceiling - Grime - Small / Overall Interior - Smell - Yes / (L) Front Seat - Grime - Small / (R) Front Seat - Grime - Small / Rear Seat - Grime - Small / Console, Switchs, Vents - Traces of Adhesive Tape - Yes / Dashboard - Worn, Scratch, Cut, Crack - Small / Steering Wheel - Worn, Peel, Crack - Small / Glove Box - Loose, Deformed - Small / Overall Interior - Animal Hair - Yes / Console, Switchs, Vents - Loose, Deformed - Small / Knobs - Worn, Peel, Crack - Small / Display, Audio System - Stuck - Yes / Room Mirror - Stuck - Yes</p>	<p>Remarks (R) Front Fender - Repair Traces - Yes / Bonnet - Repair Traces - Yes / (L) Front Fender - Repair Traces - Yes / Member (Bolted) - Dent - Yes / (L) Front Fender, Molding - Repair mark - Yes / Bonnet, Headlight - Repair mark - Yes / (R) Front Fender, Molding - Repair mark - Yes / Front Bumper, Grille, Lamps - Repair mark - Yes / Front Bumper, Grille, Lamps - Scratch - Medium / (R) Front Fender, Molding - Scratch - Minimal / (R) Front Door, Molding - Scratch & Dent - Small / (R) Rear Door, Molding - Scratch & Dent - Small / (R) Step, In-panel, Side Spoiler - Scratch & Dent - Small / (R) Rear Fender, Molding - Scratch & Dent - Medium / Roof - Dent - Medium / Trunk Hood, Rear Gate - Scratch & Dent - Small / Rear Bumper, Lamps, Panels - Scratch - Small / (L) Rear Fender, Molding - Scratch & Dent - Small / (L) Rear Door, Molding - Scratch & Dent - Small / (L) Front Door, Molding - Scratch - Small / (L) Step, In-panel, Side Spoiler - Scratch & Dent - Small / (L) Front Fender, Molding - Scratch & Dent - Small / Bonnet, Headlight - Scratch & Dent - Small / (L) Mirror - Scratch - Minimal / (R) Mirror - Scratch - Minimal</p>
