General Information

Make	Toyota	Model	Vios
YOM	2023	Odo Meter Reading	26,484
Registration No.	FAO7992	Chassis No.	PA1B18F37P4216599
CC	1.3	Transmission	CVT
Fuel Type	Gas	Type of Body	Sedan
Colour	Black

Body / Panel Condition

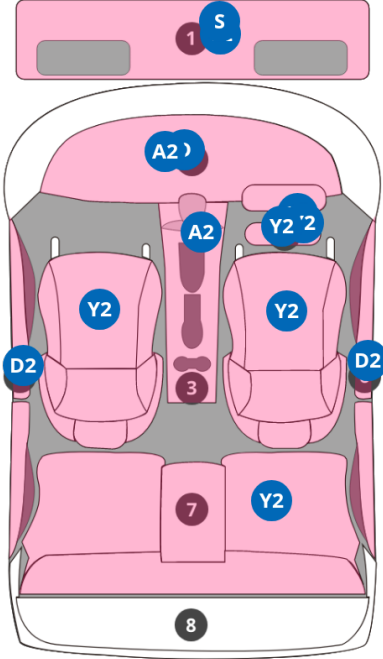
Interior Evaluation : C	Exterior Evaluation : E

<p>a : Cut, Fray d : Loose, Deformed k : Animal Hair s : Smell t : Cigarette Burns x : Defective y : Stain</p>

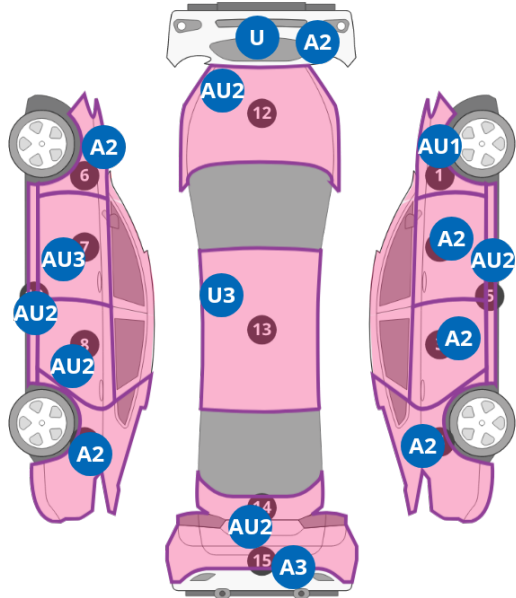
<p>A : Scratch AU : Scratch & Dent B : Modified C : Corrosion G : Stone chip P : Faded S : Rust SC : Rust & Corrosion U : Dent X : Defective Y : Crack, Gap</p>
<p>Remarks Dashboard - Traces of Adhesive Tape - Yes / Dashboard - Worn, Scratch, Cut, Crack - Small / Console, Switches, Vents - Worn, Scratch, Cut, Crack - Small / Ceiling - Grime - Small / Overall Interior - Smell - Yes / (L) Front Floor Mat - Worked - Small / (R) Front Floor Mat - Grime - Small / Mat Other - Grime - Small / (L) Front Trim - Worked - Small / (R) Front Trim - Worked - Small / (L) Front Seat - Grime - Small / (R) Front Seat - Grime - Small / Rear Seat - Grime - Small</p>	<p>Remarks (R) Front Door - Repair Traces - Yes / (R) Step - Repair Traces - Yes / (R) Front Fender - Repair Traces - Yes / Bonnet - Repair Traces - Yes / (L) Front Fender - Repair Traces - Yes / (L) Front Door - Repair Traces - Yes / (L) Step - Repair Traces - Yes / Trunk Hood, Rear Gate - Repair Traces - Yes / (R) Rear Fender - Repair Traces - Yes / (R) Rear Fender - Replaced - Yes / (R) Rear Door - Repair Traces - Yes / Roof - Repair Traces - Yes / Member (Bolted) - Dent - Yes / (L) Front Fender, Molding - Repair mark - Yes / Bonnet, Headlight - Repair mark - Yes / (R) Front Fender, Molding - Repair mark - Yes / (R) Front Door, Molding - Repair mark - Yes / (R) Rear Door, Molding - Repair mark - Yes / Trunk Hood, Rear Gate - Repair mark - Yes / Roof - Repair mark - Yes / (L) Rear Fender, Molding - Repair mark - Yes / (L) Rear Door, Molding - Repair mark - Yes / (L) Front Door, Molding - Repair mark - Yes / (L) Step, In-panel, Side Spoiler - Repair mark - Yes / (R) Step, In-panel, Side Spoiler - Repair mark - Yes / Overall Exterior - Full Re-Paint in same color - Yes / Bonnet, Headlight - Scratch & Dent - Small / Front Bumper, Grille, Lamps - Scratch - Small / (R) Front Fender, Molding - Scratch & Dent - Minimal / (R) Front Door, Molding - Scratch - Small / (R) Rear Door, Molding - Scratch - Small / (R) Step, In-panel, Side Spoiler - Scratch & Dent - Small / (R) Rear Fender, Molding - Scratch - Small / Trunk Hood, Rear Gate - Scratch & Dent - Small / Rear Bumper, Lamps, Panels - Scratch - Medium / (L) Rear Fender, Molding - Scratch - Small / (L) Rear Door, Molding - Scratch & Dent - Small / (L) Front Door, Molding - Scratch & Dent - Medium / (L) Step, In-panel, Side Spoiler - Scratch & Dent - Small / (L) Front Fender, Molding - Scratch - Small / Roof - Dent - Medium</p>
