General Information

Make	Toyota	Model	Vios
YOM	2025	Odo Meter Reading	14,545
Registration No.	GBK1090	Chassis No.	PA1B18F38S4286640
CC	1.3	Transmission	CVT
Fuel Type	Gas	Type of Body	Sedan
Colour	Red

Body / Panel Condition

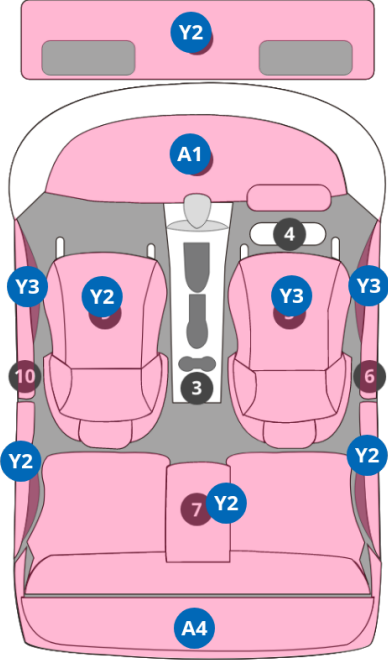
Interior Evaluation : C	Exterior Evaluation : E

<p>a : Cut, Fray d : Loose, Deformed k : Animal Hair s : Smell t : Cigarette Burns x : Defective y : Stain</p>

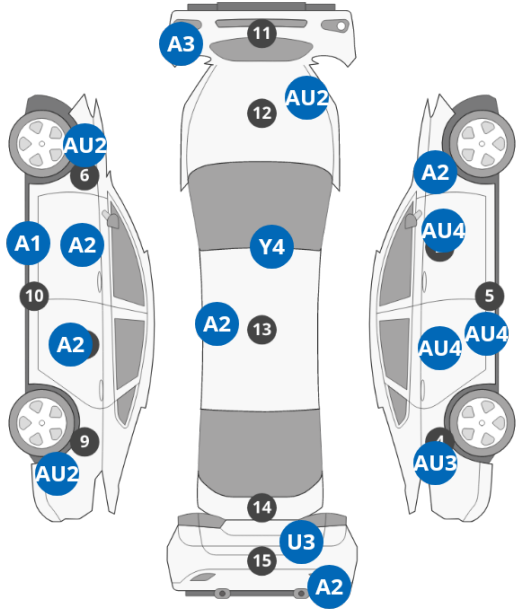
<p>A : Scratch AU : Scratch & Dent B : Modified C : Corrosion G : Stone chip P : Faded S : Rust SC : Rust & Corrosion U : Dent X : Defective Y : Crack, Gap</p>
<p>Remarks (R) Front Seat - Grime - Medium / (R) Front Trim - Grime - Medium / (L) Rear Trim - Grime - Small / (L) Front Trim - Grime - Medium / (R) Rear Trim - Grime - Small / (L) Front Seat - Grime - Small / Rear Seat - Grime - Small / Ceiling - Grime - Small / Dashboard - Worn, Scratch, Cut, Crack - Minimal / Trunk Room - Worn, Scratch, Cut, Crack - Large</p>	<p>Remarks Front Windshield - Damaged - Large / Roof - Scratch - Small / (L) Front Fender, Molding - Scratch & Dent - Small / Bonnet, Headlight - Scratch & Dent - Small / Front Bumper, Grille, Lamps - Scratch - Medium / (R) Front Fender, Molding - Scratch - Small / (R) Front Door, Molding - Scratch & Dent - Large / (R) Rear Door, Molding - Scratch & Dent - Large / (R) Step, In-panel, Side Spoiler - Scratch & Dent - Large / (R) Rear Fender, Molding - Scratch & Dent - Medium / Rear Bumper, Lamps, Panels - Scratch - Small / Trunk Hood, Rear Gate - Dent - Medium / (L) Rear Fender, Molding - Scratch & Dent - Small / (L) Rear Door, Molding - Scratch - Small / (L) Front Door, Molding - Scratch - Small / (L) Step, In-panel, Side Spoiler - Scratch - Minimal</p>
