General Information

Make	Toyota	Model	Vios
YOM	2025	Odo Meter Reading	18,711
Registration No.	FAS6752	Chassis No.	PA1B18F39R4279013
CC	1.3	Transmission	CVT
Fuel Type	Gas	Type of Body	Sedan
Colour	Red Mica Metallic

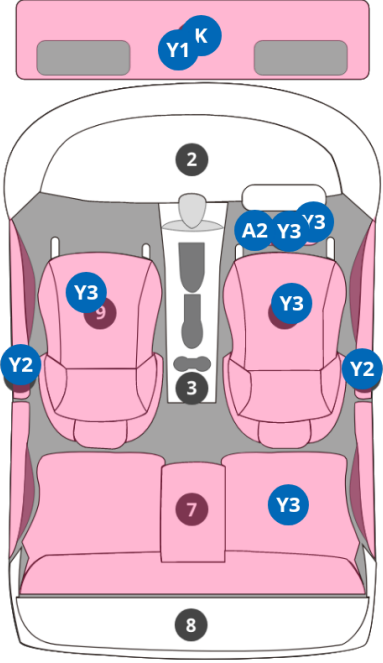
Interior Evaluation : C	Exterior Evaluation : D

<p>a : Cut, Fray d : Loose, Deformed k : Animal Hair s : Smell t : Cigarette Burns x : Defective y : Stain</p>

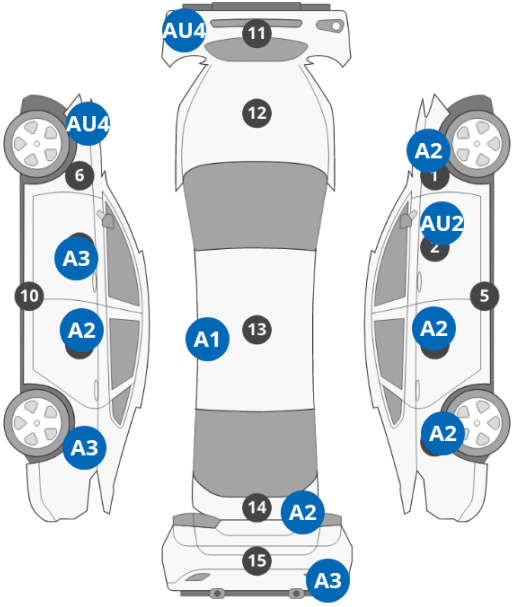
<p>A : Scratch AU : Scratch & Dent B : Modified C : Corrosion G : Stone chip P : Faded S : Rust SC : Rust & Corrosion U : Dent X : Defective Y : Crack, Gap</p>
<p>Remarks Overall Interior - Animal Hair - Yes / Ceiling - Grime - Minimal / (R) Front Floor Mat - Grime - Medium / (R) Front Trim - Grime - Small / (R) Front Seat - Grime - Medium / Rear Seat - Grime - Medium / Mat Other - Grime - Medium / (L) Front Trim - Grime - Small / (L) Front Seat - Grime - Medium / (L) Front Floor Mat - Cut, Crack - Small</p>	<p>Remarks (L) Front Fender, Molding - Scratch & Dent - Large / (R) Front Fender, Molding - Scratch - Small / (R) Rear Door, Molding - Scratch - Small / (R) Rear Fender, Molding - Scratch - Small / Trunk Hood, Rear Gate - Scratch - Small / Rear Bumper, Lamps, Panels - Scratch - Medium / (L) Rear Fender, Molding - Scratch - Medium / (L) Rear Door, Molding - Scratch - Small / (L) Front Door, Molding - Scratch - Medium / Roof - Scratch - Minimal / Front Bumper, Grille, Lamps - Scratch & Dent - Large / (R) Front Door, Molding - Scratch & Dent - Small</p>

<p>Inspector Notes</p>
<p>Both side mirror are different colors. Front bumper cover panel at right side partially missing. Gap at front bumper. With warranty booklet, spare tire, and jack. Without tools and seat cover. 1 key. With LTO plate.</p>
