General Information

Make	Ford	Model	Everest
YOM	2016	Odo Meter Reading	77,217
Registration No.	NCF4934	Chassis No.	MNCAXXMAWAGC15875
CC	2.2	Transmission	A/T
Fuel Type	Diesel	Type of Body	SUV
Colour	Red

Body / Panel Condition

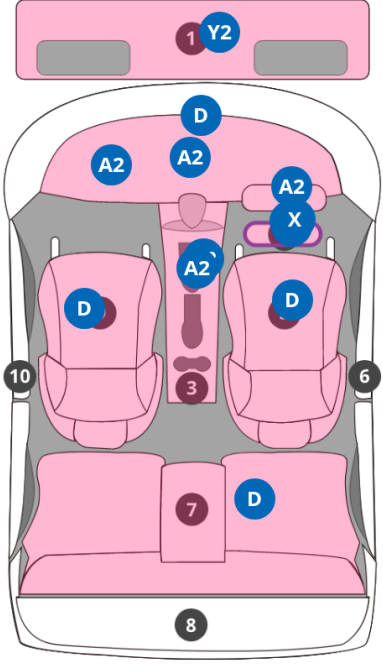
Interior Evaluation : C	Exterior Evaluation : E
<div style="text-align: center;">

</div> <p>a : Cut, Fray d : Loose, Deformed k : Animal Hair s : Smell t : Cigarette Burns x : Defective y : Stain</p>	<div style="text-align: center;">

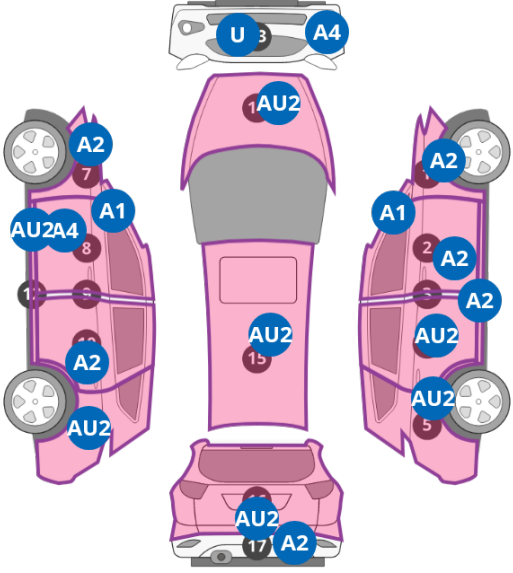
</div> <p>A : Scratch AU : Scratch & Dent B : Modified C : Corrosion G : Stone chip P : Faded S : Rust SC : Rust & Corrosion U : Dent X : Defective Y : Crack, Gap</p>
<p>Remarks Mat Other - Missing - Yes / (L) Front Floor Mat - Missing - Yes / (R) Front Floor Mat - Missing - Yes / (L) Front Seat - Worn - Yes / Dashboard - Traces of Adhesive Tape - Yes / Dashboard - Worn, Scratch, Cut, Crack - Small / Steering Wheel - Worn, Peel, Crack - Small / Glove Box - Worn, Scratch, Cut, Crack - Small / Console, Switches, Vents - Worn, Scratch, Cut, Crack - Small / Knobs - Worn, Peel, Crack - Small / Ceiling - Grime - Small / (R) Front Seat - Worn - Yes / Rear Seat - Worn - Yes</p>	<p>Remarks (R) Front Door - Repair Traces - Yes / (R) Front Fender - Repair Traces - Yes / Bonnet - Repair Traces - Yes / (L) Front Fender - Repair Traces - Yes / (L) Front Door - Repair Traces - Yes / (L) Step - Repair Traces - Yes / (L) Step - Replaced - Yes / (L) Rear Door - Repair Traces - Yes / (L) Rear Fender - Repair Traces - Yes / Trunk Hood, Rear Gate - Repair Traces - Yes / (R) Rear Fender - Repair Traces - Yes / (R) Rear Fender - Replaced - Yes / (R) Rear Door - Repair Traces - Yes / Roof - Repair Traces - Yes / (L) Rear Fender, Molding - Repair mark - Yes / (L) Rear Door, Molding - Repair mark - Yes / (L) Front Fender, Molding - Repair mark - Yes / Bonnet, Headlight - Repair mark - Yes / (R) Front Fender, Molding - Repair mark - Yes / (R) Front Door, Molding - Repair mark - Yes / (R) Rear Door, Molding - Repair mark - Yes / (R) Step, In-panel, Side Spoiler - Repair mark - Yes / (L) Step, In-panel, Side Spoiler - Repair mark - Yes / Roof - Repair mark - Yes / Trunk Hood, Rear Gate - Repair mark - Yes / Member (Bolted) - Dent - Yes / Front Bumper, Grille, Lamps - Scratch - Large / Bonnet, Headlight - Scratch & Dent - Small / (L) Front Fender, Molding - Scratch - Small / (L) Front Door, Molding - Scratch - Large / (L) Rear Door, Molding - Scratch - Small / (L) Rear Fender, Molding - Scratch & Dent - Small / Trunk Hood, Rear Gate - Scratch & Dent - Small / Rear Bumper, Lamps, Panels - Scratch - Small / (R) Rear Fender, Molding - Scratch & Dent - Small / (R) Rear Door, Molding - Scratch & Dent - Small / (R) Front Door, Molding - Scratch - Small / (R) Front Fender, Molding - Scratch - Small / (R) Step, In-panel, Side Spoiler - Scratch - Small / (L) Step, In-panel, Side Spoiler - Scratch & Dent - Small / Roof - Scratch & Dent - Small / (R) Mirror - Scratch - Minimal / (L) Mirror - Scratch - Minimal</p>
