## General Information

| Make | Mitsubishi | Model | Mirage |

## Body / Panel Condition

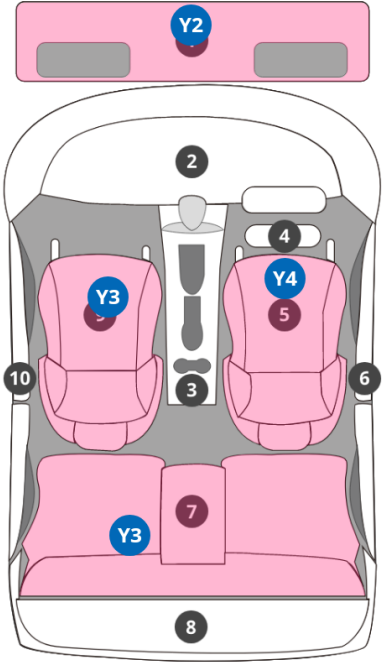
| Interior Evaluation : <span style="color: red;">C</span> | Exterior Evaluation : <span style="color: red;">D</span> |
|---|---|
| <b>Remarks</b><br>(R) Front Seat - Grime - Large / Rear Seat - Grime - Medium / (L) Front Seat - Grime - Medium / Ceiling - Grime - Small | <b>Remarks</b><br>(R) Mirror - Scratch - Small / (R) Front Door, Molding - Scratch - Small / (R) Rear Fender, Molding - Dent - Small / (R) Rear Door, Molding - Scratch - Minimal / Rear Bumper, Lamps, Panels - Scratch - Small / Trunk Hood, Rear Gate - Scratch & Dent - Medium / (L) Rear Fender, Molding - Scratch & Dent - Small / (L) Rear Door, Molding - Scratch - Small / Roof - Scratch - Small / (L) Front Fender, Molding - Dent - Medium / Front Bumper, Grille, Lamps - Scratch - Large / Bonnet, Headlight - Scratch - Medium / (L) Front Door, Molding - Scratch - Minimal / (R) Front Fender, Molding - Scratch - Minimal |
