General Information

Make	Mitsubishi	Model	Montero SPT
YOM	2019	Odo Meter Reading	86,077
Registration No.	KAD3335	Chassis No.	MMBGJKR10KH015945
CC	2.4	Transmission	M/T
Fuel Type	Diesel	Type of Body	SUV
Colour	Silver

Body / Panel Condition

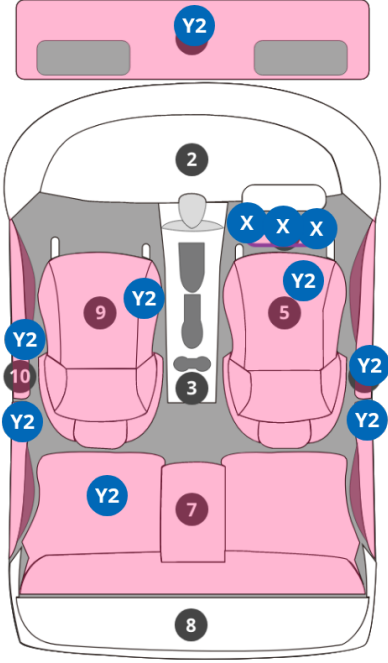
Interior Evaluation : B	Exterior Evaluation : E

<p>a : Cut, Fray d : Loose, Deformed k : Animal Hair s : Smell t : Cigarette Burns x : Defective y : Stain</p>

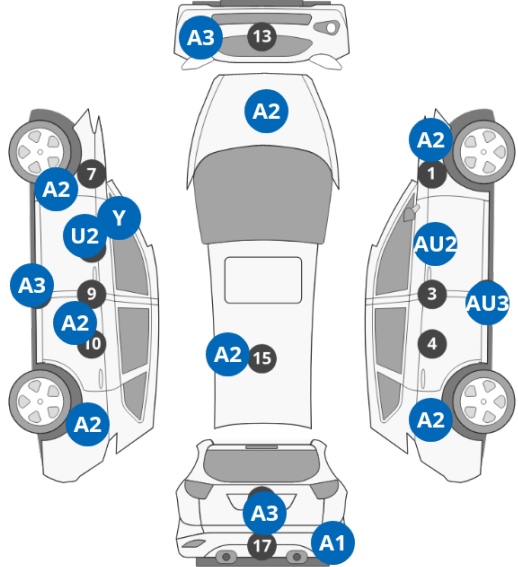
<p>A : Scratch AU : Scratch & Dent B : Modified C : Corrosion G : Stone chip P : Faded S : Rust SC : Rust & Corrosion U : Dent X : Defective Y : Crack, Gap</p>
<p>Remarks Ceiling - Grime - Small / (R) Front Trim - Grime - Small / (R) Front Floor Mat - Missing - Yes / (L) Front Floor Mat - Missing - Yes / Mat Other - Missing - Yes / (R) Rear Trim - Grime - Small / (L) Rear Trim - Grime - Small / (L) Front Trim - Grime - Small / Rear Seat - Grime - Small / (L) Front Seat - Grime - Small / (R) Front Seat - Grime - Small</p>	<p>Remarks (R) Front Door, Molding - Scratch & Dent - Small / (R) Front Fender, Molding - Scratch - Small / (R) Step, In-panel, Side Spoiler - Scratch & Dent - Medium / (R) Rear Fender, Molding - Scratch - Small / Trunk Hood, Rear Gate - Scratch - Medium / Rear Bumper, Lamps, Panels - Scratch - Minimal / (L) Rear Fender, Molding - Scratch - Small / (L) Rear Door, Molding - Scratch - Small / (L) Front Door, Molding - Dent - Small / (L) Step, In-panel, Side Spoiler - Scratch - Medium / (L) Front Fender, Molding - Scratch - Small / (L) Mirror - Crack - Cracks / Bonnet, Headlight - Scratch - Small / Front Bumper, Grille, Lamps - Scratch - Medium / Roof - Scratch - Small</p>

<p>Inspector Notes</p>
<p>Headlight not working. Yellow stains at the interior. Aircon issue. Small crack and gap at left side mirror. Without warranty booklet, jack, tools and seat cover. With spare tire. 1 key. With LTO plate.</p>
