General Information

Make	Toyota	Model	Vios
YOM	2024	Odo Meter Reading	55,671
Registration No.	NIS8403-1	Chassis No.	PA1B18F37P4230079
CC	1.3	Transmission	CVT
Fuel Type	Gas	Type of Body	Sedan
Colour	Blackish Red Mica

Body / Panel Condition

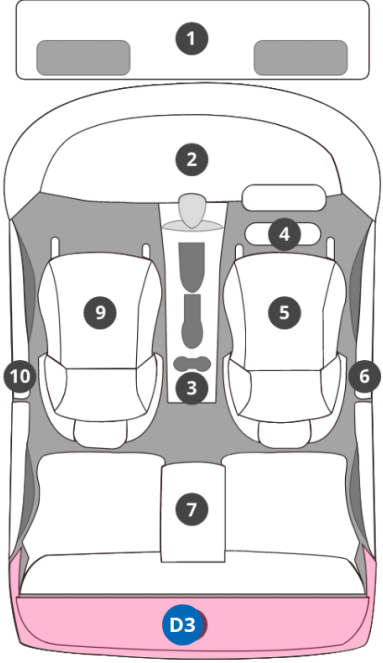
Interior Evaluation : B	Exterior Evaluation : C

<p>a : Cut, Fray d : Loose, Deformed k : Animal Hair s : Smell t : Cigarette Burns x : Defective y : Stain</p>

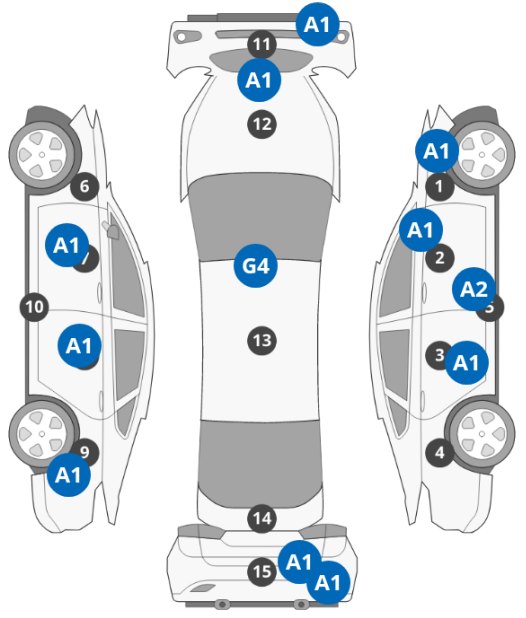
<p>A : Scratch AU : Scratch & Dent B : Modified C : Corrosion G : Stone chip P : Faded S : Rust SC : Rust & Corrosion U : Dent X : Defective Y : Crack, Gap</p>
<p>Remarks Trunk Room - Loose, Deformed - Medium</p>	<p>Remarks (R) Front Fender - Repair Traces - Yes / (L) Front Fender - Repair Traces - Yes / (R) Front Fender, Molding - Scratch - Minimal / (R) Mirror - Scratch - Minimal / (R) Front Door, Molding - Scratch - Small / (R) Rear Door, Molding - Scratch - Minimal / Rear Bumper, Lamps, Panels - Scratch - Minimal / Trunk Hood, Rear Gate - Scratch - Minimal / (L) Rear Fender, Molding - Scratch - Minimal / (L) Rear Door, Molding - Scratch - Minimal / (L) Front Door, Molding - Scratch - Minimal / Front Bumper, Grille, Lamps - Scratch - Minimal / Bonnet, Headlight - Scratch - Minimal / Front Windshield - Scratch, Stone chip - Large</p>
