## General Information

<b>Make</b>	Toyota	<b>Model</b>	Vios
<b>YOM</b>	2022	<b>Odo Meter Reading</b>	77,608
<b>Registration No.</b>	BAC5617	<b>Chassis No.</b>	PA1B18F33N4177992
<b>CC</b>	1.3	<b>Transmission</b>	CVT
<b>Fuel Type</b>	Gas	<b>Type of Body</b>	Sedan
<b>Colour</b>	Green

## Body / Panel Condition

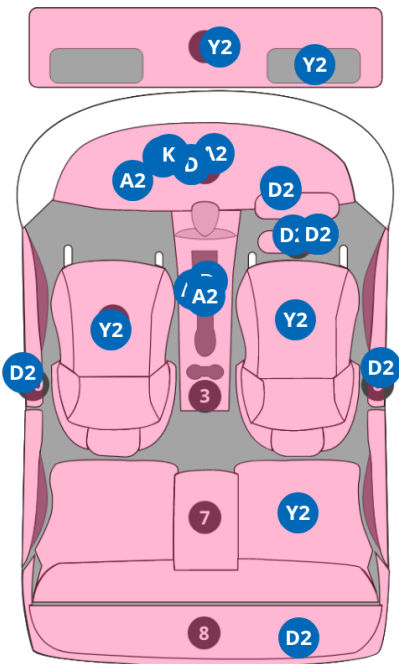
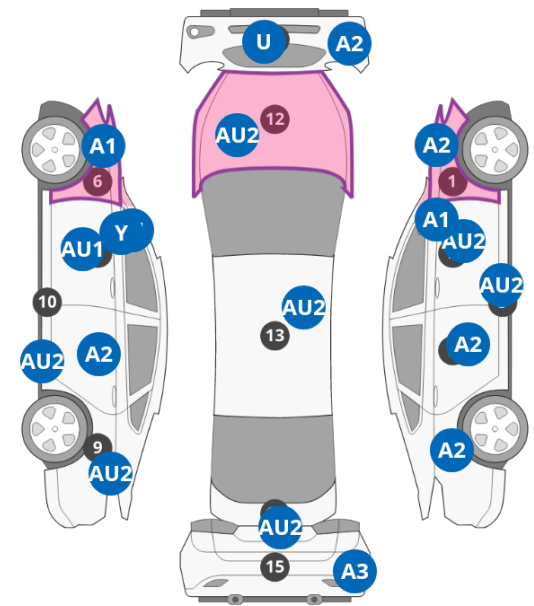
<b>Interior Evaluation :</b>	<b>E</b>	<b>Exterior Evaluation :</b>	<b>E</b>

<p><b>a</b> : Cut, Fray <b>d</b> : Loose, Deformed <b>k</b> : Animal Hair <b>s</b> : Smell <b>t</b> : Cigarette Burns <b>x</b> : Defective <b>y</b> : Stain</p>		<p><b>A</b> : Scratch <b>AU</b> : Scratch &amp; Dent <b>B</b> : Modified <b>C</b> : Corrosion <b>G</b> : Stone chip <b>P</b> : Faded <b>S</b> : Rust <b>SC</b> : Rust &amp; Corrosion <b>U</b> : Dent <b>X</b> : Defective <b>Y</b> : Crack, Gap</p>	
<p><b>Remarks</b> (L) Front Floor Mat - Worked - Small / (R) Front Floor Mat - Worked - Small / Mat Other - Worked - Small / (L) Front Trim - Worked - Small / (R) Front Trim - Worked - Small / Dashboard - Worn, Scratch, Cut, Crack - Small / Dashboard - Traces of Adhesive Tape - Yes / Steering Wheel - Worn, Peel, Crack - Small / Glove Box - Traces of Adhesive Tape - Yes / Glove Box - Loose, Deformed - Small / Overall Interior - Worn as per age - Yes / Overall Interior - Smell - Yes / Overall Interior - Animal Hair - Yes / Ceiling - Grime - Small / Sunvisor, Sunglass Holder - Grime - Small / (L) Front Seat - Grime - Small / (R) Front Seat - Grime - Small / Rear Seat - Grime - Small / Console, Switches, Vents - Worn, Scratch, Cut, Crack - Small / Console, Switches, Vents - Traces of Adhesive Tape - Yes / Knobs - Worn, Peel, Crack - Small / Room Mirror - Stuck - Yes / Display, Audio System - Stuck - Yes / Trunk Room - Loose, Deformed - Small</p>		<p><b>Remarks</b> (R) Front Fender - Repair Traces - Yes / Bonnet - Repair Traces - Yes / (L) Front Fender - Repair Traces - Yes / Trunk Hood, Rear Gate - Repair Traces - Yes / Member (Bolted) - Dent - Yes / (L) Front Fender, Molding - Repair mark - Yes / Bonnet, Headlight - Repair mark - Yes / (R) Front Fender, Molding - Repair mark - Yes / (L) Front Fender, Molding - Scratch - Minimal / (L) Front Door, Molding - Scratch &amp; Dent - Minimal / (L) Step, In-panel, Side Spoiler - Scratch &amp; Dent - Small / (L) Rear Door, Molding - Scratch - Small / (L) Rear Fender, Molding - Scratch &amp; Dent - Small / Front Bumper, Grille, Lamps - Scratch - Small / (R) Front Fender, Molding - Scratch - Small / (R) Front Door, Molding - Scratch &amp; Dent - Small / (R) Rear Door, Molding - Scratch - Small / (R) Step, In-panel, Side Spoiler - Scratch &amp; Dent - Small / (R) Rear Fender, Molding - Scratch - Small / (R) Mirror - Scratch - Minimal / Bonnet, Headlight - Scratch &amp; Dent - Small / Roof - Scratch &amp; Dent - Small / Rear Bumper, Lamps, Panels - Scratch - Medium / Trunk Hood, Rear Gate - Scratch &amp; Dent - Small / (L) Mirror - Crack - Damaged</p>
