General Information

Make	Ford	Model	Ranger
YOM	2018	Odo Meter Reading	106,646
Registration No.	CAI7692	Chassis No.	MNCUMFF50HW784429
CC	3.2	Transmission	A/T
Fuel Type	Diesel	Type of Body	Pickup
Colour	Orange

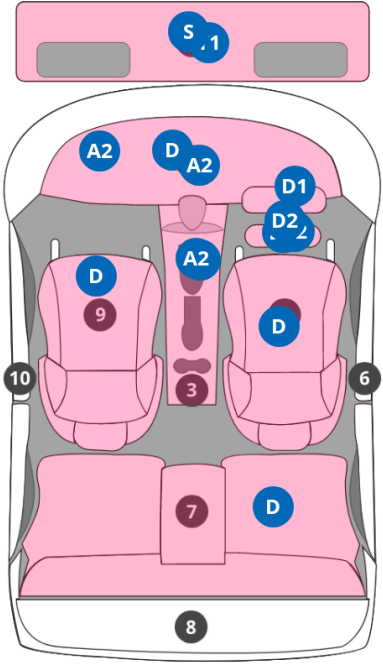
Interior Evaluation : C	Exterior Evaluation : E

<p>a : Cut, Fray d : Loose, Deformed k : Animal Hair s : Smell t : Cigarette Burns x : Defective y : Stain</p>

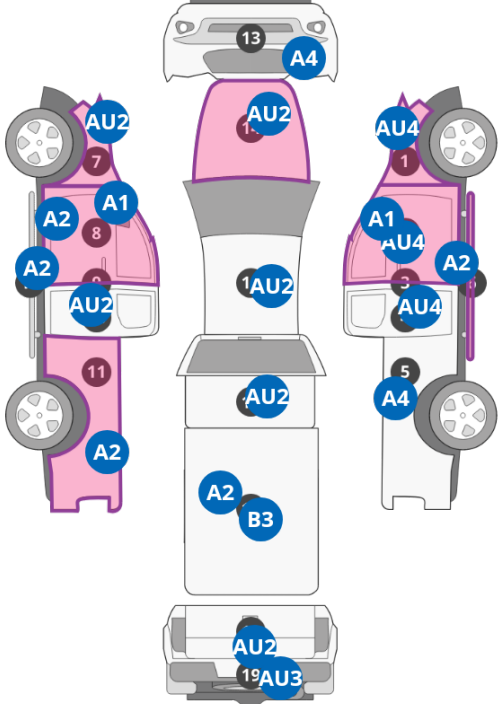
<p>A : Scratch AU : Scratch & Dent B : Modified C : Corrosion G : Stone chip P : Faded S : Rust SC : Rust & Corrosion U : Dent X : Defective Y : Crack, Gap</p>
<p>Remarks (L) Front Floor Mat - Worked - Small / (R) Front Floor Mat - Worked - Small / Mat Other - Worked - Small / Rear Seat - Worn - Yes / (R) Front Seat - Worn - Yes / (L) Front Seat - Worn - Yes / Console, Switches, Vents - Worn, Scratch, Cut, Crack - Small / Knobs - Worn, Peel, Crack - Small / Display, Audio System - Stuck - Yes / Room Mirror - Stuck - Yes / Dashboard - Traces of Adhesive Tape - Yes / Dashboard - Worn, Scratch, Cut, Crack - Small / Steering Wheel - Worn, Peel, Crack - Small / Glove Box - Loose, Deformed - Minimal / Ceiling - Grime - Minimal / Overall Interior - Smell - Yes</p>	<p>Remarks (R) Front Door - Repair Traces - Yes / (R) Step - Repair Traces - Yes / (R) Front Fender - Repair Traces - Yes / Bonnet - Repair Traces - Yes / (L) Front Fender - Repair Traces - Yes / (L) Front Door - Repair Traces - Yes / (L) Rear Corner Panel - Repair Traces - Yes / Roof - Repair Traces - Yes / Front Bumper, Grille, Lamps - Scratch - Large / (R) Front Door, Molding - Repair mark - Yes / (R) Front Fender, Molding - Repair mark - Yes / Bonnet, Headlight - Repair mark - Yes / (L) Front Fender, Molding - Repair mark - Yes / (L) Front Door, Molding - Repair mark - Yes / (R) Step, In-panel, Side Spoiler - Repair mark - Yes / (L) Side Gate - Repair mark - Yes / (R) Front Fender, Molding - Scratch & Dent - Large / (R) Front Door, Molding - Scratch & Dent - Large / (R) Rear Door, Molding - Scratch & Dent - Large / (R) Side Gate - Scratch - Large / Rear Gate - Scratch & Dent - Small / Rear Bumper, Lamps, Panels - Scratch & Dent - Medium / (L) Side Gate - Scratch - Small / (L) Rear Door, Molding - Scratch & Dent - Small / (L) Front Door, Molding - Scratch - Small / (L) Step, In-panel, Side Spoiler - Scratch - Small / (R) Step, In-panel, Side Spoiler - Scratch - Small / (L) Front Fender, Molding - Scratch & Dent - Small / (L) Mirror - Scratch - Minimal / (R) Mirror - Scratch - Minimal / Bonnet, Headlight - Scratch & Dent - Small / Cargo Bed Floor - Modified - Medium / Cargo Bed Floor - Scratch - Small / Cab Back Panel - Scratch & Dent - Small / Roof - Scratch & Dent - Small</p>
