General Information

Make	Geely	Model	Emgrand
YOM	2023	Odo Meter Reading	19,819
Registration No.	DBI5309	Chassis No.	LB3F3102XPG012561
CC	1.5	Transmission	CVT
Fuel Type	Gas	Type of Body	Sedan
Colour	Blue

Body / Panel Condition

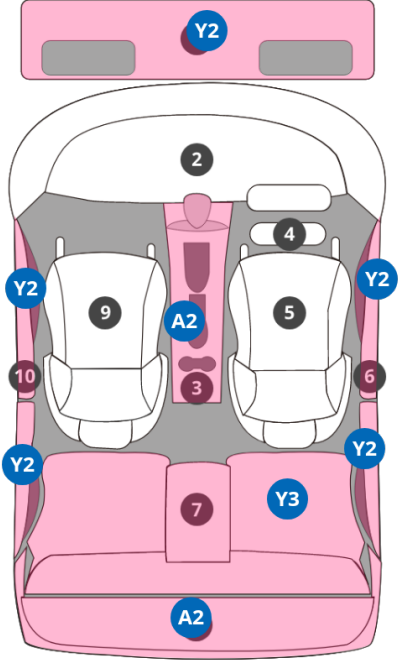
Interior Evaluation : B	Exterior Evaluation : E

<p>a : Cut, Fray d : Loose, Deformed k : Animal Hair s : Smell t : Cigarette Burns x : Defective y : Stain</p>

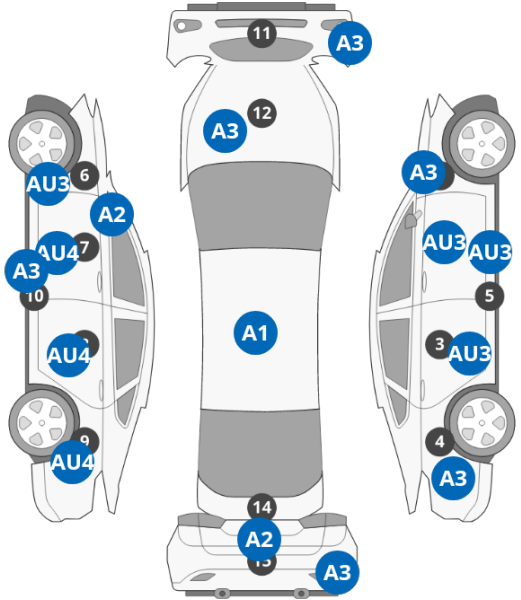
<p>A : Scratch AU : Scratch & Dent B : Modified C : Corrosion G : Stone chip P : Faded S : Rust SC : Rust & Corrosion U : Dent X : Defective Y : Crack, Gap</p>
<p>Remarks Rear Seat - Grime - Medium / (R) Front Trim - Grime - Small / (R) Rear Trim - Grime - Small / (L) Rear Trim - Grime - Small / (L) Front Trim - Grime - Small / Ceiling - Grime - Small / Trunk Room - Worn, Scratch, Cut, Crack - Small / Console, Switchs, Vents - Worn, Scratch, Cut, Crack - Small</p>	<p>Remarks Front Bumper, Grille, Lamps - Scratch - Medium / (R) Front Fender, Molding - Scratch - Medium / (R) Front Door, Molding - Scratch & Dent - Medium / (R) Step, In-panel, Side Spoiler - Scratch & Dent - Medium / (R) Rear Door, Molding - Scratch & Dent - Medium / (R) Rear Fender, Molding - Scratch - Medium / Rear Bumper, Lamps, Panels - Scratch - Medium / Trunk Hood, Rear Gate - Scratch - Small / (L) Rear Fender, Molding - Scratch & Dent - Large / (L) Rear Door, Molding - Scratch & Dent - Large / (L) Front Door, Molding - Scratch & Dent - Large / (L) Step, In-panel, Side Spoiler - Scratch - Medium / (L) Front Fender, Molding - Scratch & Dent - Medium / (L) Mirror - Scratch - Small / Bonnet, Headlight - Scratch - Medium / Roof - Scratch - Minimal</p>
