General Information

Make	Mitsubishi	Model	Montero SPT
YOM	2024	Odo Meter Reading	11,930
Registration No.	DBO5224	Chassis No.	MMBGJKR10RH00382
CC	2.4	Transmission	M/T
Fuel Type	Diesel	Type of Body	SUV
Colour	Silver

Body / Panel Condition

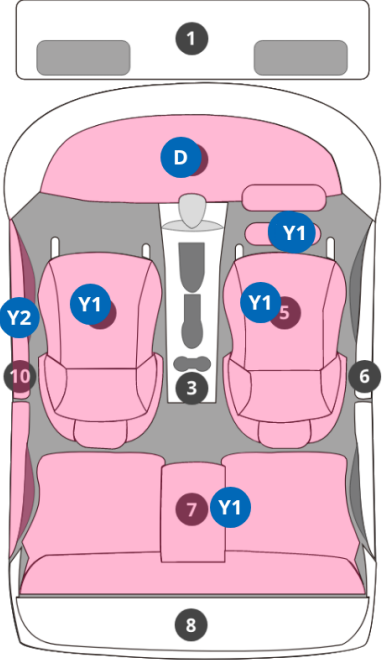
Interior Evaluation : A	Exterior Evaluation : C

<p>a : Cut, Fray d : Loose, Deformed k : Animal Hair s : Smell t : Cigarette Burns x : Defective y : Stain</p>

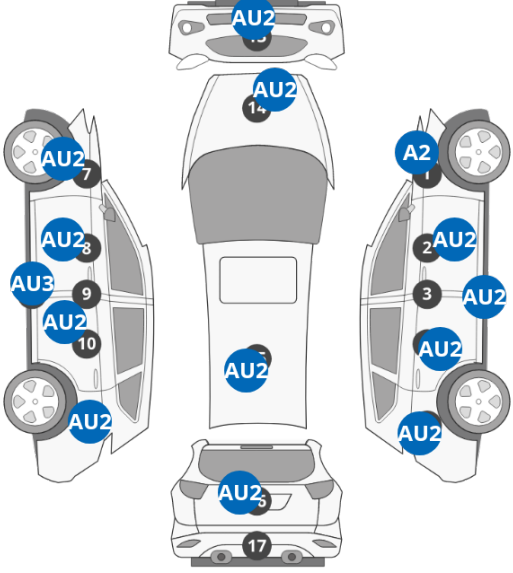
<p>A : Scratch AU : Scratch & Dent B : Modified C : Corrosion G : Stone chip P : Faded S : Rust SC : Rust & Corrosion U : Dent X : Defective Y : Crack, Gap</p>
<p>Remarks Dashboard - Traces of Adhesive Tape - Yes / (R) Front Floor Mat - Grime - Minimal / (L) Front Floor Mat - Grime - Minimal / (L) Front Seat - Grime - Minimal / (R) Front Seat - Grime - Minimal / Rear Seat - Grime - Minimal / (L) Front Trim - Grime - Small</p>	<p>Remarks (L) Rear Fender, Molding - Scratch & Dent - Small / Trunk Hood, Rear Gate - Scratch & Dent - Small / (R) Rear Fender, Molding - Scratch & Dent - Small / (R) Rear Door, Molding - Scratch & Dent - Small / (R) Front Door, Molding - Scratch & Dent - Small / (R) Step, In-panel, Side Spoiler - Scratch & Dent - Small / (R) Front Fender, Molding - Scratch - Small / Bonnet, Headlight - Scratch & Dent - Small / (L) Front Fender, Molding - Scratch & Dent - Small / (L) Front Door, Molding - Scratch & Dent - Small / (L) Rear Door, Molding - Scratch & Dent - Small / (L) Step, In-panel, Side Spoiler - Scratch & Dent - Medium / Roof - Scratch & Dent - Small / Front Bumper, Grille, Lamps - Scratch & Dent - Small</p>
