General Information

Make	Toyota	Model	Vios
YOM	2024	Odo Meter Reading	26,358
Registration No.	BAF9937	Chassis No.	PA1B18F35R4247949
CC	1.3	Transmission	CVT
Fuel Type	Gas	Type of Body	Sedan
Colour	Blackish Red Mica

Body / Panel Condition

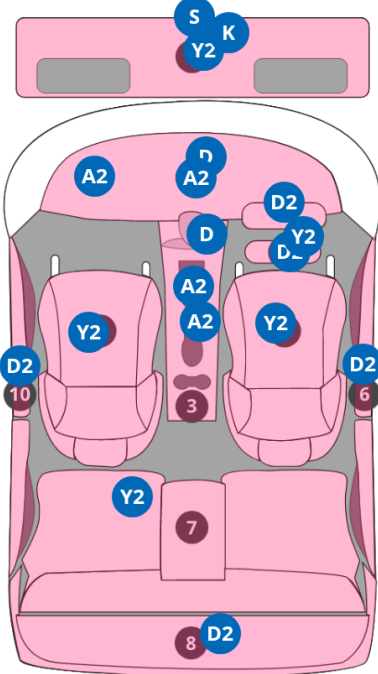
Interior Evaluation : D	Exterior Evaluation : E

<p>a : Cut, Fray d : Loose, Deformed k : Animal Hair s : Smell t : Cigarette Burns x : Defective y : Stain</p>
