General Information

Make	Mazda	Model	BT50
YOM	2023	Odo Meter Reading	9,144
Registration No.	FAP3010	Chassis No.	MP2TFS40JNT031153
CC	3.0	Transmission	A/T
Fuel Type	Diesel	Type of Body	Double Cab. Pick-Up
Colour	Red

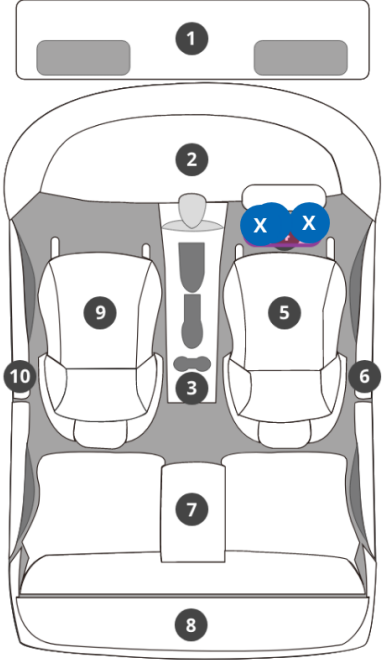
Interior Evaluation : C	Exterior Evaluation : E

<p>a : Cut, Fray d : Loose, Deformed k : Animal Hair s : Smell t : Cigarette Burns x : Defective y : Stain</p>

<p>A : Scratch AU : Scratch & Dent B : Modified C : Corrosion G : Stone chip P : Faded S : Rust SC : Rust & Corrosion U : Dent X : Defective Y : Crack, Gap</p>
<p>Remarks Overall Interior - Worn as per age - Yes / (R) Front Floor Mat - Missing - Yes / (L) Front Floor Mat - Missing - Yes / Mat Other - Missing - Yes</p>	<p>Remarks (L) Side Gate - Scratch - Large / Rear Gate - Scratch & Dent - Large / Rear Bumper, Lamps, Panels - Scratch & Dent - Large / (R) Side Gate - Modified - Large / (L) Side Gate - Modified - Large / (R) Side Gate - Scratch & Dent - Large / (R) Rear Door, Molding - Scratch - Large / (R) Front Door, Molding - Scratch - Large / Front Bumper, Grille, Lamps - Scratch & Dent - Large / (R) Front Fender, Molding - Crack, Gap - Small / Bonnet, Headlight - Scratch - Large / (L) Front Fender, Molding - Scratch - Large / (L) Front Door, Molding - Scratch - Large / (L) Rear Door, Molding - Scratch - Large / (L) Step, In-panel, Side Spoiler - Scratch - Large</p>
