General Information

Make	Nissan	Model	Terra
YOM	2019	Odo Meter Reading	86,026
Registration No.	ZAB8367	Chassis No.	MNTJCAD23Z0008804
CC	2.5	Transmission	M/T
Fuel Type	Diesel	Type of Body	SUV
Colour	White

Body / Panel Condition

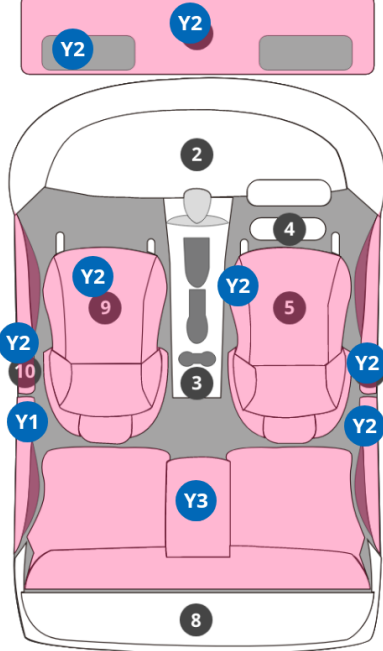
Interior Evaluation : C	Exterior Evaluation : D

<p>a : Cut, Fray d : Loose, Deformed k : Animal Hair s : Smell t : Cigarette Burns x : Defective y : Stain</p>

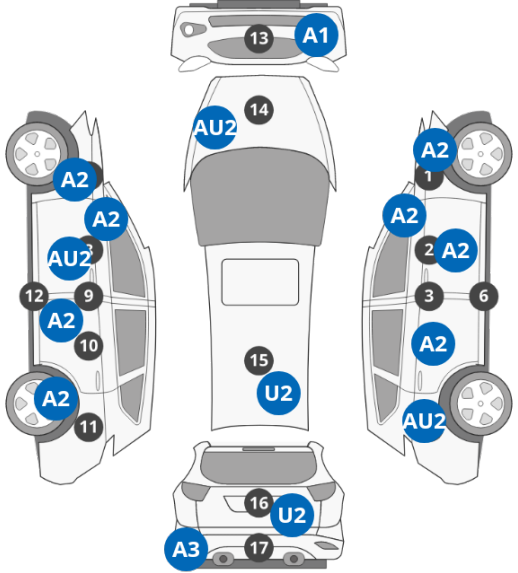
<p>A : Scratch AU : Scratch & Dent B : Modified C : Corrosion G : Stone chip P : Faded S : Rust SC : Rust & Corrosion U : Dent X : Defective Y : Crack, Gap</p>
<p>Remarks Ceiling - Grime - Small / Sunvisor, Sunglass Holder - Grime - Small / (R) Front Trim - Grime - Small / (R) Front Seat - Grime - Small / Rear Seat - Grime - Medium / (R) Rear Trim - Grime - Small / (L) Rear Trim - Grime - Minimal / (L) Front Trim - Grime - Small / (L) Front Seat - Grime - Small</p>	<p>Remarks (R) Mirror - Scratch - Small / (R) Front Door, Molding - Scratch - Small / (R) Rear Door, Molding - Scratch - Small / (R) Rear Fender, Molding - Scratch & Dent - Small / Trunk Hood, Rear Gate - Dent - Small / Rear Bumper, Lamps, Panels - Scratch - Medium / (L) Rear Fender, Molding - Scratch - Small / (L) Rear Door, Molding - Scratch - Small / (L) Front Door, Molding - Scratch & Dent - Small / (L) Mirror - Scratch - Small / (L) Front Fender, Molding - Scratch - Small / Front Bumper, Grille, Lamps - Scratch - Minimal / (R) Front Fender, Molding - Scratch - Small / Roof - Dent - Small / Bonnet, Headlight - Scratch & Dent - Small</p>
