General Information

Make	Toyota	Model	Vios
YOM	2024	Odo Meter Reading	23,654
Registration No.	CCA8776	Chassis No.	PA1B18F3XR4254458
CC	1.3	Transmission	CVT
Fuel Type	Gas	Type of Body	Sedan
Colour	Silver

Body / Panel Condition

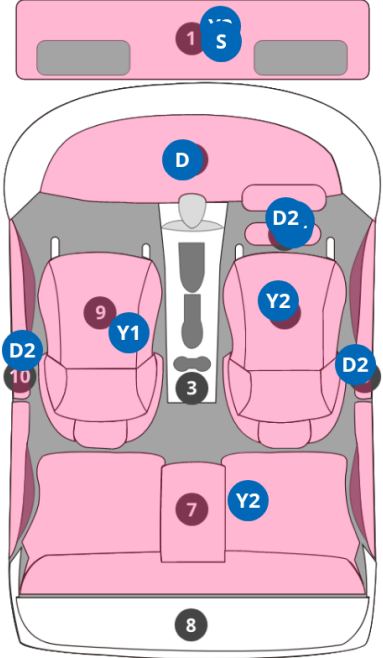
Interior Evaluation : C	Exterior Evaluation : E

<p>a : Cut, Fray d : Loose, Deformed k : Animal Hair s : Smell t : Cigarette Burns x : Defective y : Stain</p>

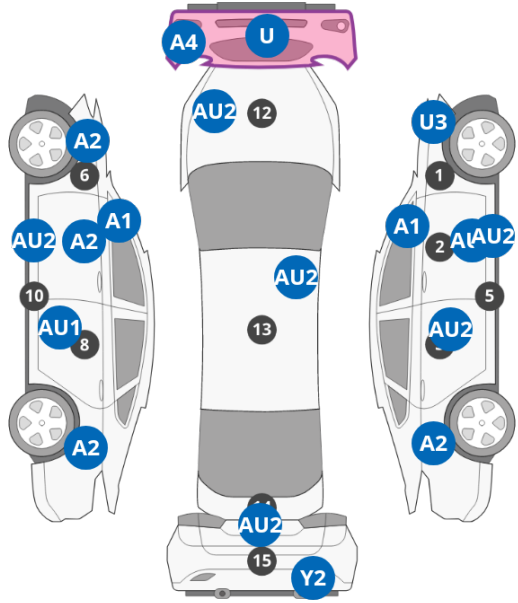
<p>A : Scratch AU : Scratch & Dent B : Modified C : Corrosion G : Stone chip P : Faded S : Rust SC : Rust & Corrosion U : Dent X : Defective Y : Crack, Gap</p>
<p>Remarks (L) Front Floor Mat - Worked - Small / (R) Front Floor Mat - Worked - Small / Mat Other - Worked - Small / (L) Front Trim - Worked - Small / (R) Front Trim - Worked - Small / Dashboard - Traces of Adhesive Tape - Yes / Rear Seat - Grime - Small / (L) Front Seat - Grime - Minimal / (R) Front Seat - Grime - Small / Ceiling - Grime - Small / Overall Interior - Smell - Yes</p>	<p>Remarks Member (Bolted) - Dent - Yes / Front Bumper, Grille, Lamps - Scratch - Large / Front Bumper, Grille, Lamps - Repair mark - Yes / (R) Front Fender, Molding - Dent - Medium / (R) Rear Door, Molding - Scratch & Dent - Small / (R) Front Door, Molding - Scratch & Dent - Large / (R) Step, In-panel, Side Spoiler - Scratch & Dent - Small / (R) Rear Fender, Molding - Scratch - Small / Trunk Hood, Rear Gate - Scratch & Dent - Small / Rear Bumper, Lamps, Panels - Crack, Gap - Small / (L) Rear Fender, Molding - Scratch - Small / (L) Rear Door, Molding - Scratch & Dent - Minimal / (L) Front Door, Molding - Scratch - Small / (L) Step, In-panel, Side Spoiler - Scratch & Dent - Small / (L) Front Fender, Molding - Scratch - Small / Bonnet, Headlight - Scratch & Dent - Small / Roof - Scratch & Dent - Small / (L) Mirror - Scratch - Minimal / (R) Mirror - Scratch - Minimal</p>
