General Information

Make	Toyota	Model	Vios
YOM	2025	Odo Meter Reading	8,511
Registration No.	CCG7007	Chassis No.	PA1B18F32S4289386
CC	1.3	Transmission	CVT
Fuel Type	Gas	Type of Body	Sedan
Colour	Red

Body / Panel Condition

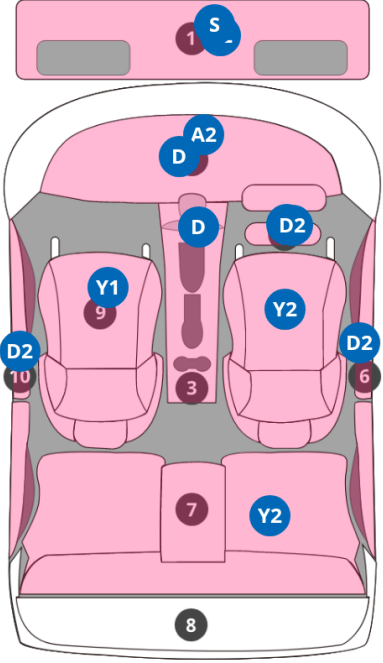
Interior Evaluation : C	Exterior Evaluation : D

<p>a : Cut, Fray d : Loose, Deformed k : Animal Hair s : Smell t : Cigarette Burns x : Defective y : Stain</p>

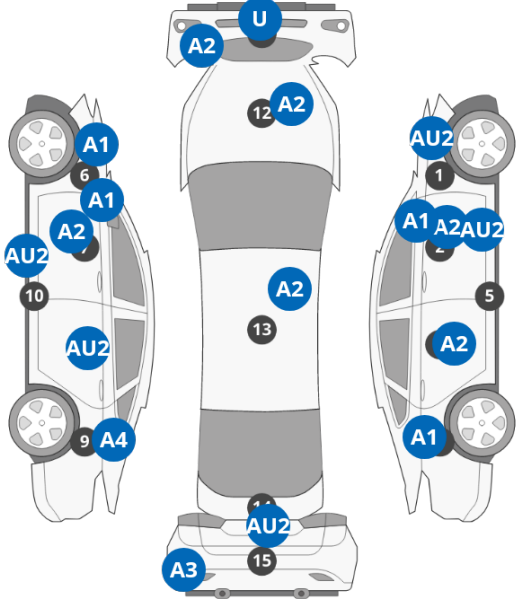
<p>A : Scratch AU : Scratch & Dent B : Modified C : Corrosion G : Stone chip P : Faded S : Rust SC : Rust & Corrosion U : Dent X : Defective Y : Crack, Gap</p>
Remarks (L) Front Floor Mat - Worked - Small / Mat Other - Worked - Small / (L) Front Seat - Grime - Minimal / (R) Front Seat - Grime - Small / (L) Front Trim - Worked - Small / (R) Front Trim - Worked - Small / Dashboard - Worn, Scratch, Cut, Crack - Small / Dashboard - Traces of Adhesive Tape - Yes / Console, Switches, Vents - Traces of Adhesive Tape - Yes / Ceiling - Grime - Small / Overall Interior - Smell - Yes / Rear Seat - Grime - Small	Remarks Member (Bolted) - Dent - Yes / (L) Rear Fender, Molding - Scratch - Large / Rear Bumper, Lamps, Panels - Scratch - Medium / (L) Rear Door, Molding - Scratch & Dent - Small / (L) Front Door, Molding - Scratch - Small / (L) Step, In-panel, Side Spoiler - Scratch & Dent - Small / (L) Front Fender, Molding - Scratch - Minimal / Front Bumper, Grille, Lamps - Scratch - Small / (R) Rear Fender, Molding - Scratch - Minimal / (R) Rear Door, Molding - Scratch - Small / (R) Front Door, Molding - Scratch - Small / (R) Front Fender, Molding - Scratch & Dent - Small / (R) Step, In-panel, Side Spoiler - Scratch & Dent - Small / Roof - Scratch - Small / Trunk Hood, Rear Gate - Scratch & Dent - Small / Bonnet, Headlight - Scratch - Small / (L) Mirror - Scratch - Minimal / (R) Mirror - Scratch - Minimal
