General Information

Make	Toyota	Model	Hilux
YOM	2024	Odo Meter Reading	24,870
Registration No.	CBB5976	Chassis No.	MR0AB8DD8P5036950
CC	2.4	Transmission	A/T
Fuel Type	Diesel	Type of Body	Pickup
Colour	White

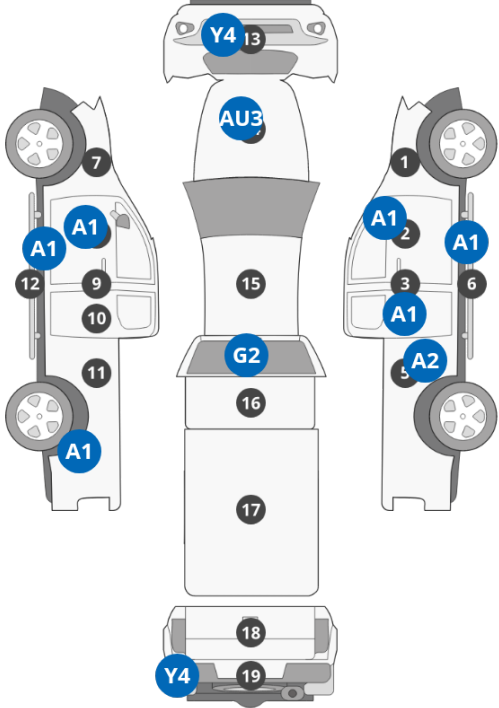
<p>A : Scratch AU : Scratch & Dent B : Modified C : Corrosion G : Stone chip P : Faded S : Rust SC : Rust & Corrosion U : Dent X : Defective Y : Crack, Gap</p>
Remarks Defects not found	Remarks (R) Center Panel - Repair Traces - Yes / (R) Mirror - Scratch - Minimal / (R) Step, In-panel, Side Spoiler - Scratch - Minimal / (R) Rear Door, Molding - Scratch - Minimal / (R) Side Gate - Scratch - Small / Rear Bumper, Lamps, Panels - Crack, Gap - Large / (L) Side Gate - Scratch - Minimal / (L) Step, In-panel, Side Spoiler - Scratch - Minimal / (L) Front Door, Molding - Scratch - Minimal / Bonnet, Headlight - Scratch & Dent - Medium / Front Bumper, Grille, Lamps - Crack, Gap - Large / Front Windshield - Scratch, Stone chip - Small
Frame Evaluation : B	Functional Evaluation : C
