General Information

Make	Toyota	Model	Innova
YOM	2025	Odo Meter Reading	12,708
Registration No.	NKO3176	Chassis No.	PA2JA8EM8S0153255
CC	2.8	Transmission	A/T
Fuel Type	Diesel	Type of Body	Wagon
Colour	Silver

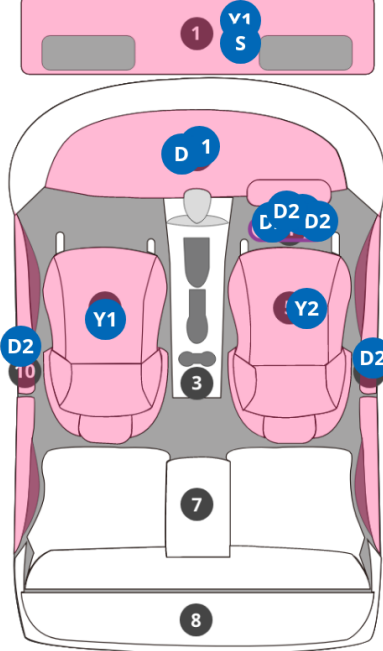
<p>a : Cut, Fray d : Loose, Deformed k : Animal Hair s : Smell t : Cigarette Burns x : Defective y : Stain</p>

<p>A : Scratch AU : Scratch & Dent B : Modified C : Corrosion G : Stone chip P : Faded S : Rust SC : Rust & Corrosion U : Dent X : Defective Y : Crack, Gap</p>
<p>Remarks (L) Front Floor Mat - Missing - Yes / Ceiling - Grime - Minimal / Overall Interior - Smell - Yes / Dashboard - Worn, Scratch, Cut, Crack - Minimal / Dashboard - Traces of Adhesive Tape - Yes / (R) Front Seat - Grime - Small / (L) Front Trim - Worked - Small / (R) Front Trim - Worked - Small / (L) Front Seat - Grime - Minimal / (R) Front Floor Mat - Worked - Small / Mat Other - Worked - Small / (L) Front Floor Mat - Worked - Small</p>	<p>Remarks Member (Bolted) - Dent - Yes / Front Bumper, Grille, Lamps - Scratch - Medium / (R) Front Fender, Molding - Scratch - Small / (R) Front Door, Molding - Scratch & Dent - Large / (R) Step, In-panel, Side Spoiler - Scratch & Dent - Medium / (R) Rear Door, Molding - Scratch & Dent - Large / (R) Rear Fender, Molding - Scratch - Medium / Trunk Hood, Rear Gate - Scratch & Dent - Small / Rear Bumper, Lamps, Panels - Scratch - Medium / (L) Rear Fender, Molding - Scratch & Dent - Medium / (L) Rear Door, Molding - Scratch & Dent - Small / (L) Front Door, Molding - Scratch - Small / (L) Step, In-panel, Side Spoiler - Scratch & Dent - Small / (L) Front Fender, Molding - Scratch - Small / (L) Mirror - Scratch - Minimal / (R) Mirror - Scratch - Minimal / Bonnet, Headlight - Scratch & Dent - Small / Roof - Scratch & Dent - Small</p>
