General Information

Make	Nissan	Model	Navara
YOM	2023	Odo Meter Reading	32,062
Registration No.	KAP8971	Chassis No.	MNTCCAD23Z0015475
CC	2.5	Transmission	M/T
Fuel Type	Diesel	Type of Body	Pickup
Colour	Silver

Body / Panel Condition

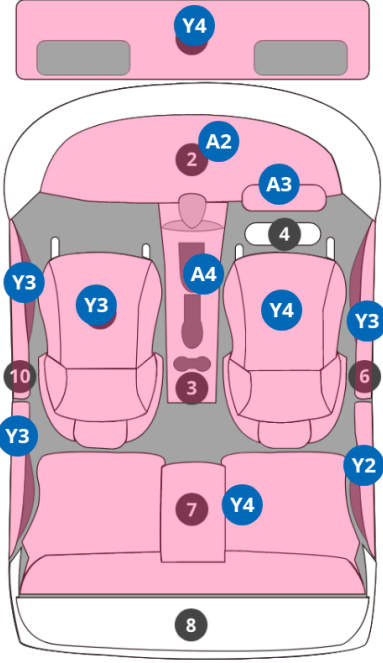
Interior Evaluation : E	Exterior Evaluation : E

<p>a : Cut, Fray d : Loose, Deformed k : Animal Hair s : Smell t : Cigarette Burns x : Defective y : Stain</p>

<p>A : Scratch AU : Scratch & Dent B : Modified C : Corrosion G : Stone chip P : Faded S : Rust SC : Rust & Corrosion U : Dent X : Defective Y : Crack, Gap</p>
<p>Remarks (R) Front Seat - Grime - Large / (R) Front Trim - Grime - Medium / Rear Seat - Grime - Large / (R) Rear Trim - Grime - Small / (L) Rear Trim - Grime - Medium / (L) Front Trim - Grime - Medium / (L) Front Seat - Grime - Medium / Steering Wheel - Worn, Peel, Crack - Medium / Console, Switchs, Vents - Worn, Scratch, Cut, Crack - Large / Ceiling - Grime - Large / Dashboard - Worn, Scratch, Cut, Crack - Small</p>	<p>Remarks Rear Bumper, Lamps, Panels - Crack, Gap - Large / (R) Side Gate - Scratch & Dent - Medium / (R) Rear Door, Molding - Scratch - Medium / (R) Front Fender, Molding - Scratch & Dent - Medium / (R) Front Door, Molding - Scratch & Dent - Medium / Front Bumper, Grille, Lamps - Scratch - Large / (L) Front Fender, Molding - Scratch & Dent - Large / Bonnet, Headlight - Scratch - Small / (L) Front Door, Molding - Scratch - Medium / (L) Rear Door, Molding - Scratch - Medium / (L) Side Gate - Scratch - Small / Rear Gate - Scratch & Dent - Medium / Rear Windshield - Scratch, Stone chip - Small / Cargo Bed Floor - Scratch - Large / Roof - Scratch - Medium</p>
