General Information

Make	Toyota	Model	Vios
YOM	2025	Odo Meter Reading	9,059
Registration No.	DBR8651	Chassis No.	PA1B18F35T4279560
CC	1.3	Transmission	CVT
Fuel Type	Gas	Type of Body	Sedan
Colour	Blackish Red Mica

Body / Panel Condition

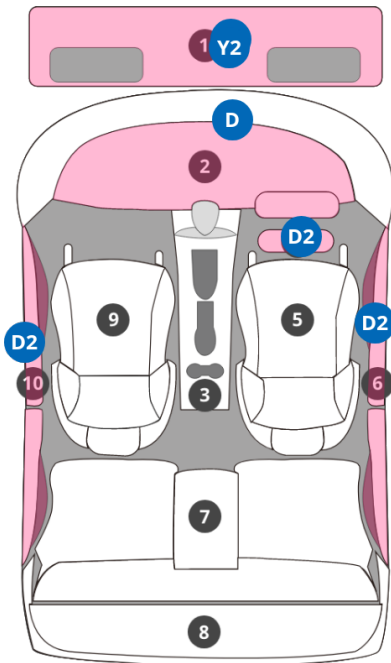
<p>a : Cut, Fray d : Loose, Deformed k : Animal Hair s : Smell t : Cigarette Burns x : Defective y : Stain</p>

<p>A : Scratch AU : Scratch & Dent B : Modified C : Corrosion G : Stone chip P : Faded S : Rust SC : Rust & Corrosion U : Dent X : Defective Y : Crack, Gap</p>
<p>Remarks (L) Front Floor Mat - Worked - Small / (L) Front Trim - Worked - Small / (R) Front Trim - Worked - Small / Dashboard - Traces of Adhesive Tape - Yes / Overall Interior - Smell - Yes / Ceiling - Grime - Small</p>	<p>Remarks (L) Rear Door - Repair Traces - Yes / (L) Rear Door, Molding - Scratch - Small / (L) Front Door, Molding - Scratch - Small / (L) Step, In-panel, Side Spoiler - Scratch - Minimal / (L) Rear Fender, Molding - Repair mark - Yes / (L) Rear Fender, Molding - Scratch - Small / (L) Front Fender, Molding - Scratch & Dent - Small / Member (Bolted) - Dent - Yes / Bonnet, Headlight - Scratch & Dent - Small / Front Bumper, Grille, Lamps - Scratch - Small / (R) Front Fender, Molding - Scratch & Dent - Minimal / (R) Front Door, Molding - Scratch - Small / (R) Rear Door, Molding - Scratch - Large / (R) Step, In-panel, Side Spoiler - Scratch & Dent - Small / (R) Rear Fender, Molding - Scratch - Medium / Trunk Hood, Rear Gate - Scratch & Dent - Small / Roof - Scratch - Small / Rear Bumper, Lamps, Panels - Scratch - Small</p>
