General Information

Make	Toyota	Model	Vios
YOM	2025	Odo Meter Reading	3,428
Registration No.	CCQ1202	Chassis No.	PA1B18F38S4288100
CC	1.3	Transmission	CVT
Fuel Type	Gas	Type of Body	Sedan
Colour	Blue

Body / Panel Condition

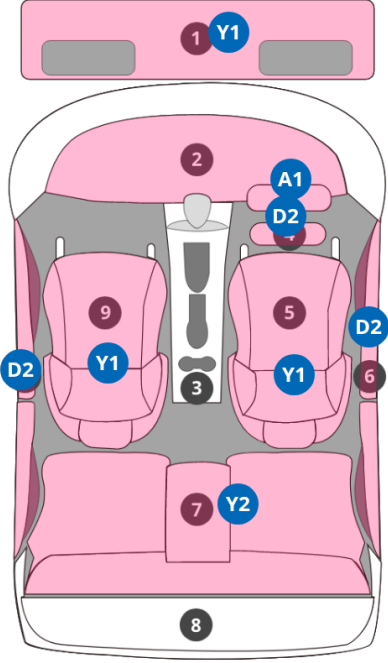
Interior Evaluation : B	Exterior Evaluation : E

<p>a : Cut, Fray d : Loose, Deformed k : Animal Hair s : Smell t : Cigarette Burns x : Defective y : Stain</p>

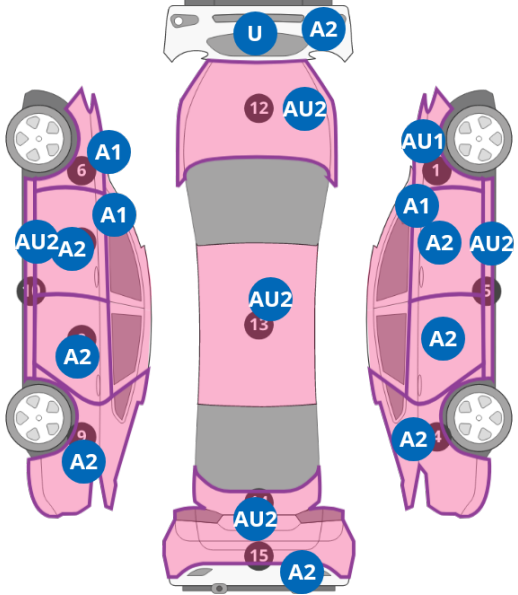
<p>A : Scratch AU : Scratch & Dent B : Modified C : Corrosion G : Stone chip P : Faded S : Rust SC : Rust & Corrosion U : Dent X : Defective Y : Crack, Gap</p>
<p>Remarks (L) Front Trim - Worked - Small / (L) Front Floor Mat - Worked - Small / Ceiling - Grime - Minimal / (R) Front Trim - Worked - Small / (L) Front Seat - Grime - Minimal / (R) Front Seat - Grime - Minimal / Glove Box - Worn, Scratch, Cut, Crack - Minimal / Rear Seat - Grime - Small</p>	<p>Remarks (R) Front Door - Repair Traces - Yes / (R) Step - Repair Traces - Yes / (R) Step - Replaced - Yes / (R) Front Fender - Repair Traces - Yes / Bonnet - Repair Traces - Yes / (L) Front Fender - Repair Traces - Yes / (L) Front Door - Repair Traces - Yes / (L) Step - Repair Traces - Yes / (L) Rear Door - Repair Traces - Yes / (L) Rear Fender - Repair Traces - Yes / Trunk Hood, Rear Gate - Repair Traces - Yes / Rear End Panel - Repair Traces - Yes / (R) Rear Fender - Repair Traces - Yes / (R) Rear Fender - Replaced - Yes / (R) Rear Door - Repair Traces - Yes / Roof - Repair Traces - Yes / Roof - Replaced - Yes / (L) Rear Fender, Molding - Repair mark - Yes / (L) Rear Door, Molding - Repair mark - Yes / (L) Front Door, Molding - Repair mark - Yes / (L) Step, In-panel, Side Spoiler - Repair mark - Yes / (L) Front Fender, Molding - Repair mark - Yes / Bonnet, Headlight - Repair mark - Yes / (R) Front Fender, Molding - Repair mark - Yes / (R) Front Door, Molding - Repair mark - Yes / (R) Rear Door, Molding - Repair mark - Yes / (R) Step, In-panel, Side Spoiler - Repair mark - Yes / (R) Rear Fender, Molding - Repair mark - Yes / Member (Bolted) - Dent - Yes / Trunk Hood, Rear Gate - Repair mark - Yes / (L) Front Fender, Molding - Scratch - Minimal / Bonnet, Headlight - Scratch & Dent - Small / Front Bumper, Grille, Lamps - Scratch - Small / (R) Front Fender, Molding - Scratch & Dent - Minimal / (R) Front Door, Molding - Scratch - Small / (R) Step, In-panel, Side Spoiler - Scratch & Dent - Small / (R) Rear Door, Molding - Scratch - Small / (R) Rear Fender, Molding - Scratch - Small / Trunk Hood, Rear Gate - Scratch & Dent - Small / Rear Bumper, Lamps, Panels - Scratch - Small / (L) Rear Fender, Molding - Scratch - Small / (L) Rear Door, Molding - Scratch - Small / (L) Front Door, Molding - Scratch - Small / (L) Step, In-panel, Side Spoiler - Scratch & Dent - Small / (L) Mirror - Scratch - Minimal / (R) Mirror - Scratch - Minimal / Roof - Scratch & Dent - Small</p>
