## General Information

<b>Make</b>	Toyota	<b>Model</b>	Wigo
<b>YOM</b>	2023	<b>Odo Meter Reading</b>	22,274
<b>Registration No.</b>	BAF3070	<b>Chassis No.</b>	MHKAA4DF5FPJ081353
<b>CC</b>	1.0	<b>Transmission</b>	A/T
<b>Fuel Type</b>	Gas	<b>Type of Body</b>	Hatchback
<b>Colour</b>	Orange

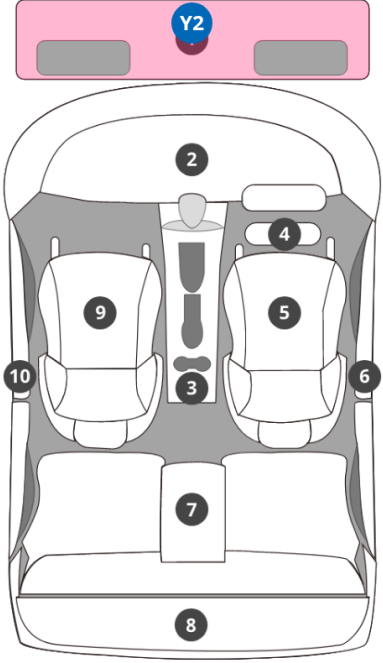
<p><b>a</b> : Cut, Fray <b>d</b> : Loose, Deformed <b>k</b> : Animal Hair <b>s</b> : Smell <b>t</b> : Cigarette Burns <b>x</b> : Defective <b>y</b> : Stain</p>

<p><b>A</b> : Scratch <b>AU</b> : Scratch &amp; Dent <b>B</b> : Modified <b>C</b> : Corrosion <b>G</b> : Stone chip <b>P</b> : Faded <b>S</b> : Rust <b>SC</b> : Rust &amp; Corrosion <b>U</b> : Dent <b>X</b> : Defective <b>Y</b> : Crack, Gap</p>
<b>Remarks</b> Ceiling - Grime - Small	<b>Remarks</b> (R) Front Door, Molding - Scratch - Minimal / (R) Rear Fender, Molding - Scratch - Minimal / (L) Rear Fender, Molding - Scratch - Minimal / (L) Rear Door, Molding - Scratch - Minimal / (L) Front Door, Molding - Scratch & Dent - Minimal / (L) Mirror - Scratch - Minimal / (L) Front Fender, Molding - Scratch & Dent - Minimal / Front Bumper, Grille, Lamps - Scratch & Dent - Small / Bonnet, Headlight - Scratch - Minimal

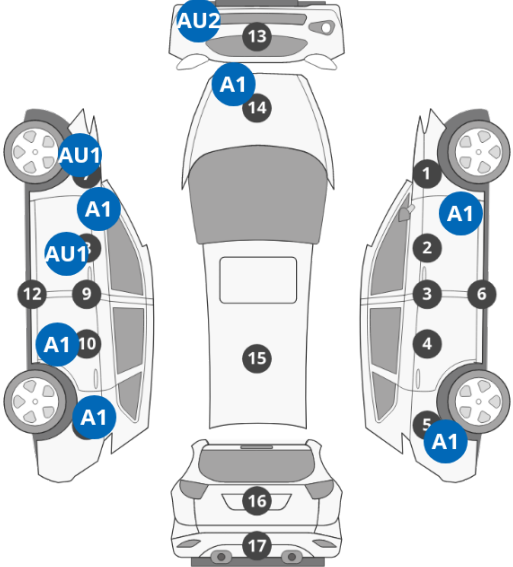
<b>Inspector Notes</b>
With Lto plate, with warranty booklet, with spare and jack, 2keys, no tools,scratches on headlight
