General Information

Make	Mazda	Model	Mazda 3
YOM	2019	Odo Meter Reading	42,202
Registration No.	NEI4436	Chassis No.	JM8BN14A0K1247024
CC	1.5	Transmission	A/T
Fuel Type	Gas	Type of Body	Hatchback
Colour	Gray

Body / Panel Condition

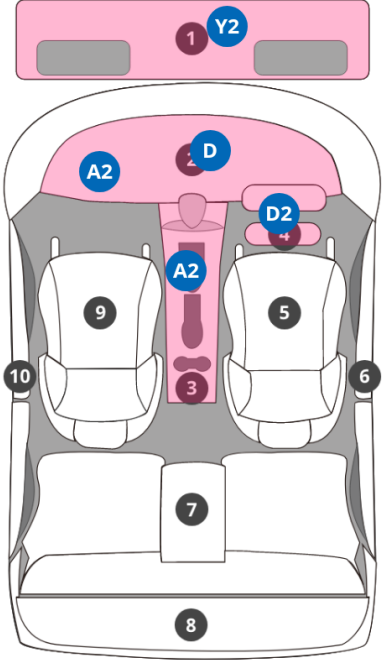
Interior Evaluation : B	Exterior Evaluation : D

<p>a : Cut, Fray d : Loose, Deformed k : Animal Hair s : Smell t : Cigarette Burns x : Defective y : Stain</p>

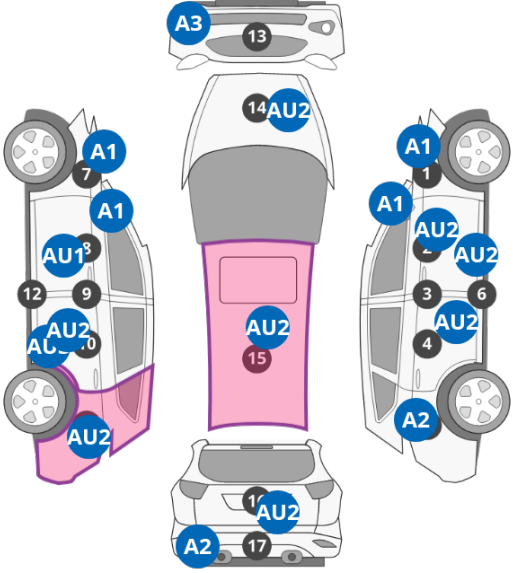
<p>A : Scratch AU : Scratch & Dent B : Modified C : Corrosion G : Stone chip P : Faded S : Rust SC : Rust & Corrosion U : Dent X : Defective Y : Crack, Gap</p>
<p>Remarks (L) Front Floor Mat - Worked - Small / Dashboard - Traces of Adhesive Tape - Yes / Steering Wheel - Worn, Peel, Crack - Small / Ceiling - Grime - Small / Knobs - Worn, Peel, Crack - Small</p>	<p>Remarks (L) Rear Fender - Repair Traces - Yes / Roof - Repair Traces - Yes / Roof - Repair mark - Yes / (L) Rear Fender, Molding - Repair mark - Yes / Overall Exterior - Faded(Color, Gloss) - Yes / Front Bumper, Grille, Lamps - Scratch - Medium / Bonnet, Headlight - Scratch & Dent - Small / (R) Front Fender, Molding - Scratch - Minimal / (R) Front Door, Molding - Scratch & Dent - Small / (R) Rear Door, Molding - Scratch & Dent - Small / (R) Step, In-panel, Side Spoiler - Scratch & Dent - Small / (R) Rear Fender, Molding - Scratch - Small / Roof - Scratch & Dent - Small / Trunk Hood, Rear Gate - Scratch & Dent - Small / Rear Bumper, Lamps, Panels - Scratch - Small / (L) Rear Fender, Molding - Scratch & Dent - Small / (L) Step, In-panel, Side Spoiler - Scratch & Dent - Medium / (L) Rear Door, Molding - Scratch & Dent - Small / (L) Front Door, Molding - Scratch & Dent - Minimal / (L) Front Fender, Molding - Scratch - Minimal / (L) Mirror - Scratch - Minimal / (R) Mirror - Scratch - Minimal</p>
