General Information

Make	Nissan	Model	NP300 Navara
YOM	2019	Odo Meter Reading	238,737
Registration No.	LAG3264	Chassis No.	MNTCC4D23Z0052315
CC	2.5	Transmission	A/T
Fuel Type	Diesel	Type of Body	Pickup
Colour	Silver

Body / Panel Condition

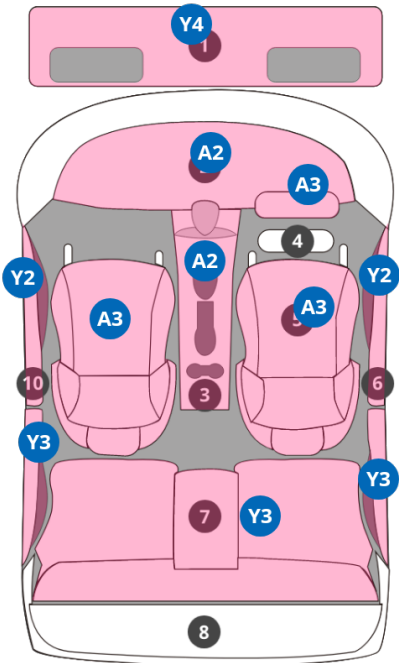
Interior Evaluation : E	Exterior Evaluation : E

<p>a : Cut, Fray d : Loose, Deformed k : Animal Hair s : Smell t : Cigarette Burns x : Defective y : Stain</p>

<p>A : Scratch AU : Scratch & Dent B : Modified C : Corrosion G : Stone chip P : Faded S : Rust SC : Rust & Corrosion U : Dent X : Defective Y : Crack, Gap</p>
Remarks (R) Front Seat - Cut, Crack - Medium / (R) Front Trim - Grime - Small / Rear Seat - Grime - Medium / (R) Rear Trim - Grime - Medium / (L) Rear Trim - Grime - Medium / (L) Front Seat - Cut, Crack - Medium / (L) Front Trim - Grime - Small / Ceiling - Grime - Large / Steering Wheel - Worn, Peel, Crack - Medium / Dashboard - Worn, Scratch, Cut, Crack - Small / Console, Switches, Vents - Worn, Scratch, Cut, Crack - Small	Remarks (L) Side Gate - Scratch & Dent - Medium / Rear Bumper, Lamps, Panels - Scratch & Dent - Medium / Rear Gate - Scratch & Dent - Medium / Rear Windshield - Scratch, Stone chip - Medium / Roof - Dent - Small / Cargo Bed Floor - Scratch - Small / (L) Front Door, Molding - Scratch & Dent - Medium / (L) Rear Door, Molding - Scratch - Small / (L) Front Fender, Molding - Scratch & Dent - Large / Bonnet, Headlight - Scratch & Dent - Small / Front Bumper, Grille, Lamps - Scratch & Dent - Large / (R) Front Fender, Molding - Scratch & Dent - Medium / (R) Front Door, Molding - Scratch & Dent - Medium / (R) Step, In-panel, Side Spoiler - Scratch - Medium / (R) Rear Door, Molding - Scratch & Dent - Small / (R) Side Gate - Scratch & Dent - Medium
