General Information

Make	Mitsubishi	Model	Mirage
YOM	2025	Odo Meter Reading	1,133
Registration No.	NEZ3696	Chassis No.	PAEA13RJSRA001277
CC	1.2	Transmission	CVT
Fuel Type	Gas	Type of Body	Sedan
Colour	Silver

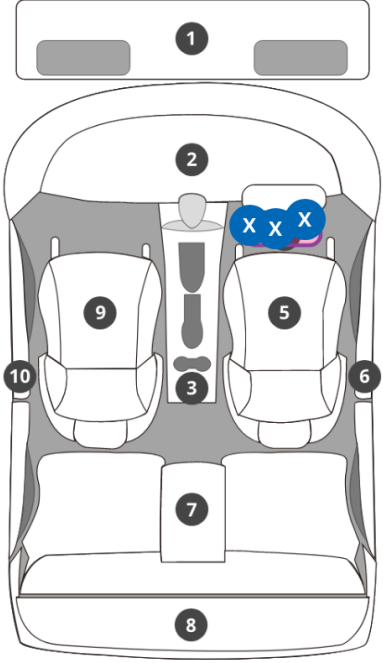
Interior Evaluation : B	Exterior Evaluation : B

<p>a : Cut, Fray d : Loose, Deformed k : Animal Hair s : Smell t : Cigarette Burns x : Defective y : Stain</p>

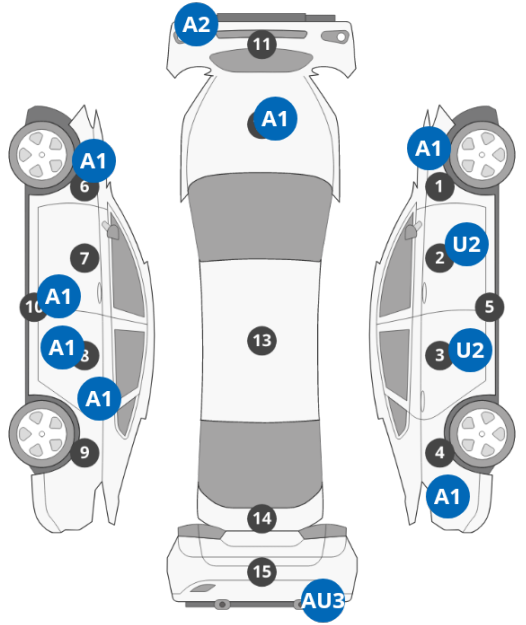
<p>A : Scratch AU : Scratch & Dent B : Modified C : Corrosion G : Stone chip P : Faded S : Rust SC : Rust & Corrosion U : Dent X : Defective Y : Crack, Gap</p>
<p>Remarks (R) Front Floor Mat - Missing - Yes / (L) Front Floor Mat - Missing - Yes / Mat Other - Missing - Yes</p>	<p>Remarks (R) Rear Door, Molding - Dent - Small / (R) Front Door, Molding - Dent - Small / Bonnet, Headlight - Scratch - Minimal / (L) Front Fender, Molding - Scratch - Minimal / Front Bumper, Grille, Lamps - Scratch - Small / (L) Front Door, Molding - Scratch - Minimal / (L) Rear Fender, Molding - Scratch - Minimal / Rear Bumper, Lamps, Panels - Scratch & Dent - Medium / (L) Rear Door, Molding - Scratch - Minimal / (R) Rear Fender, Molding - Scratch - Minimal / (R) Front Fender, Molding - Scratch - Minimal</p>
