General Information

Make	Mitsubishi	Model	L300
YOM	2025	Odo Meter Reading	10,795
Registration No.	NFM8787	Chassis No.	PAEL65MYSRB024614
CC	2.2	Transmission	M/T
Fuel Type	Diesel	Type of Body	FB Body
Colour	White

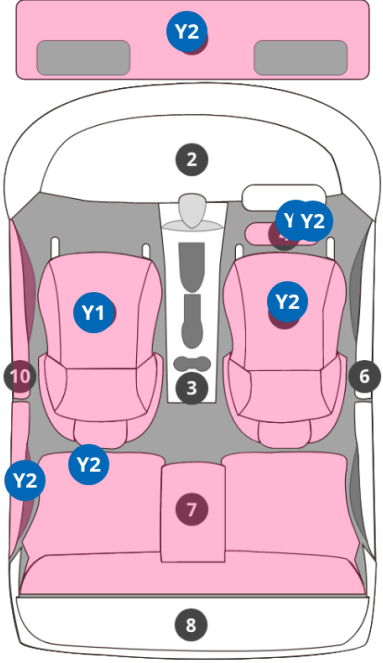
Interior Evaluation : B	Exterior Evaluation : D

<p>a : Cut, Fray d : Loose, Deformed k : Animal Hair s : Smell t : Cigarette Burns x : Defective y : Stain</p>

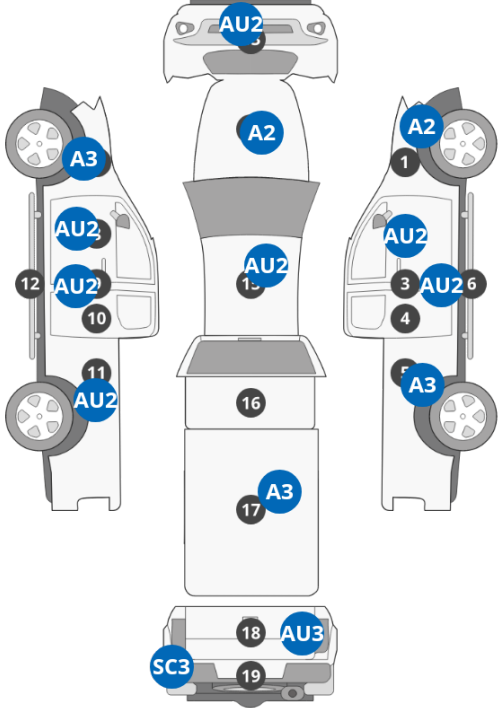
<p>A : Scratch AU : Scratch & Dent B : Modified C : Corrosion G : Stone chip P : Faded S : Rust SC : Rust & Corrosion U : Dent X : Defective Y : Crack, Gap</p>
<p>Remarks (L) Front Seat - Grime - Minimal / (R) Front Seat - Grime - Small / Rear Seat - Grime - Small / (R) Front Floor Mat - Grime - Small / (L) Front Floor Mat - Grime - Small / Trim Other - Grime - Small / Ceiling - Grime - Small</p>	<p>Remarks (L) Center Panel - Scratch & Dent - Small / (L) Front Door, Molding - Scratch & Dent - Small / Front Panel - Scratch - Small / (R) Front Fender, Molding - Scratch - Small / Front Bumper, Grille, Lamps - Scratch & Dent - Small / (L) Front Fender, Molding - Scratch - Medium / (R) Front Door, Molding - Scratch & Dent - Small / (R) Center Panel - Scratch & Dent - Small / (R) Side Gate - Scratch - Medium / Rear Bumper, Lamps, Panels - Rust, Corrosion - Medium / Rear Gate - Scratch & Dent - Medium / (L) Side Gate - Scratch & Dent - Small / Roof - Scratch & Dent - Small</p>
