General Information

Make	Mitsubishi	Model	Xpander
YOM	2023	Odo Meter Reading	30,433
Registration No.	NIS8020	Chassis No.	MK2LRNC1WPN03021
CC	1.5	Transmission	A/T
Fuel Type	Gas	Type of Body	Wagon
Colour	White

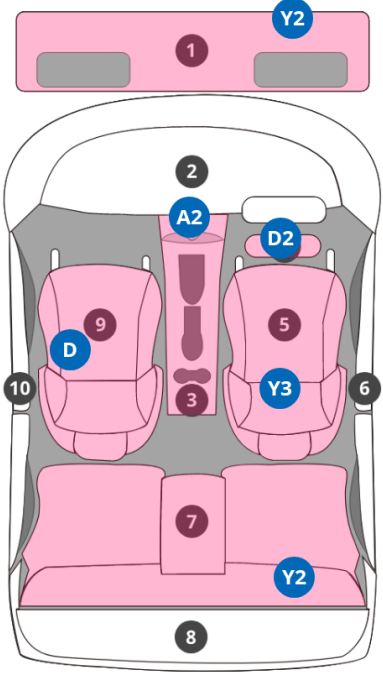
Interior Evaluation : B	Exterior Evaluation : B

<p>a : Cut, Fray d : Loose, Deformed k : Animal Hair s : Smell t : Cigarette Burns x : Defective y : Stain</p>

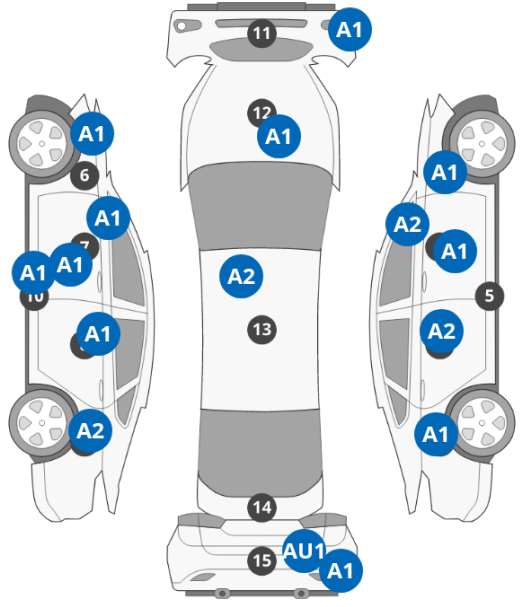
<p>A : Scratch AU : Scratch & Dent B : Modified C : Corrosion G : Stone chip P : Faded S : Rust SC : Rust & Corrosion U : Dent X : Defective Y : Crack, Gap</p>
<p>Remarks (R) Front Seat - Grime - Medium / (L) Front Floor Mat - Worked - Small / Console, Switches, Vents - Worn, Scratch, Cut, Crack - Small / Ceiling - Grime - Small / Rear Seat - Grime - Small / (L) Front Seat - Worn - Yes</p>	<p>Remarks (R) Front Fender, Molding - Scratch - Minimal / (R) Mirror - Scratch - Small / (R) Front Door, Molding - Scratch - Minimal / (R) Rear Door, Molding - Scratch - Small / (R) Rear Fender, Molding - Scratch - Minimal / Trunk Hood, Rear Gate - Scratch & Dent - Minimal / Rear Bumper, Lamps, Panels - Scratch - Minimal / (L) Rear Fender, Molding - Scratch - Small / (L) Rear Door, Molding - Scratch - Minimal / (L) Step, In-panel, Side Spoiler - Scratch - Minimal / (L) Front Door, Molding - Scratch - Minimal / (L) Mirror - Scratch - Minimal / (L) Front Fender, Molding - Scratch - Minimal / Front Bumper, Grille, Lamps - Scratch - Minimal / Bonnet, Headlight - Scratch - Minimal / Roof - Scratch - Small</p>

<p>Inspector Notes</p>
<p>with warranty booklet, jack and tools, with spare tire, with LTO plate, scratches on tail light</p>
