General Information

Make	Mitsubishi	Model	XForce
YOM	2025	Odo Meter Reading	16,501
Registration No.	NKE6415	Chassis No.	MK2XTGR1WSN01010
CC	1.5	Transmission	CVT
Fuel Type	Gas	Type of Body	SUV
Colour	Silver

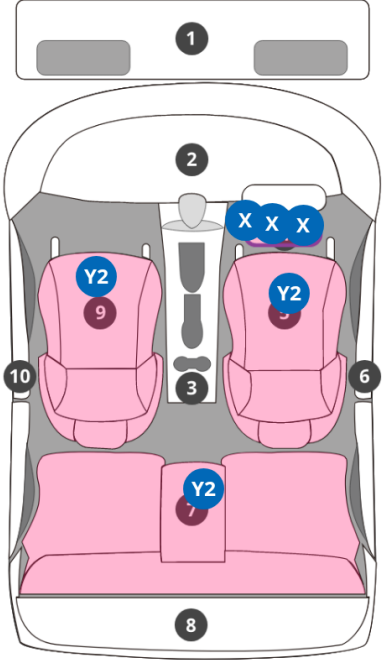
Interior Evaluation : B	Exterior Evaluation : B

<p>a : Cut, Fray d : Loose, Deformed k : Animal Hair s : Smell t : Cigarette Burns x : Defective y : Stain</p>

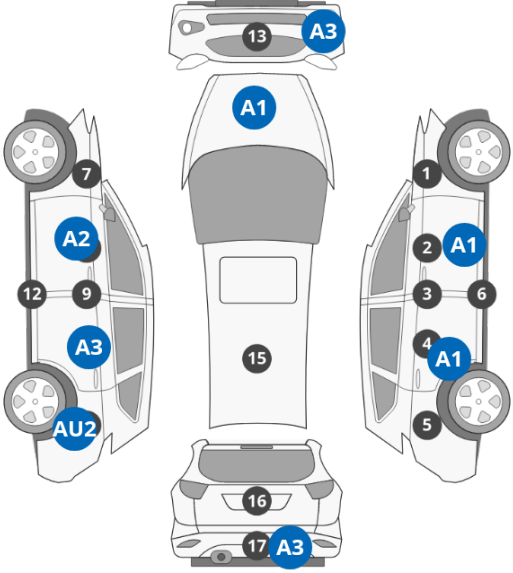
<p>A : Scratch AU : Scratch & Dent B : Modified C : Corrosion G : Stone chip P : Faded S : Rust SC : Rust & Corrosion U : Dent X : Defective Y : Crack, Gap</p>
Remarks Rear Seat - Grime - Small / (R) Front Seat - Grime - Small / (L) Front Seat - Grime - Small / (R) Front Floor Mat - Missing - Yes / (L) Front Floor Mat - Missing - Yes / Mat Other - Missing - Yes	Remarks (L) Front Fender - Repair Traces - Yes / Front Bumper, Grille, Lamps - Scratch - Medium / Rear Bumper, Lamps, Panels - Scratch - Medium / (L) Rear Door, Molding - Scratch - Medium / (L) Rear Fender, Molding - Scratch & Dent - Small / (L) Front Door, Molding - Scratch - Small / (R) Front Door, Molding - Scratch - Minimal / (R) Rear Door, Molding - Scratch - Minimal / Bonnet, Headlight - Scratch - Minimal
