General Information

Make	Mitsubishi	Model	L300
YOM	2025	Odo Meter Reading	13,986
Registration No.	NKF2536	Chassis No.	PAEL65MYSRB024300
CC	2.2	Transmission	M/T
Fuel Type	Gas	Type of Body	FB Body
Colour	White

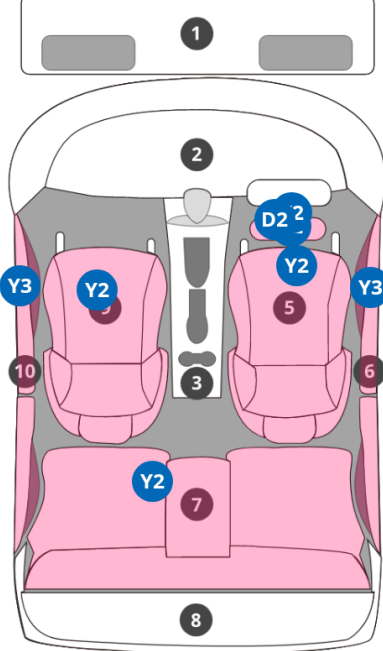
Interior Evaluation : C	Exterior Evaluation : D

<p>a : Cut, Fray d : Loose, Deformed k : Animal Hair s : Smell t : Cigarette Burns x : Defective y : Stain</p>

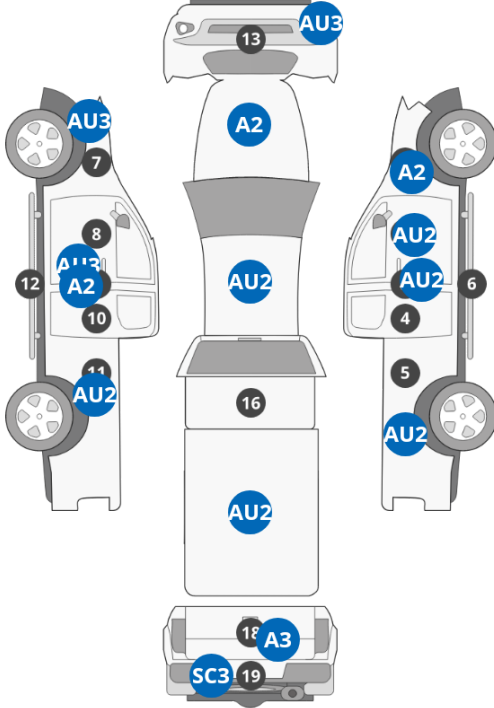
<p>A : Scratch AU : Scratch & Dent B : Modified C : Corrosion G : Stone chip P : Faded S : Rust SC : Rust & Corrosion U : Dent X : Defective Y : Crack, Gap</p>
<p>Remarks Rear Seat - Grime - Small / (R) Front Floor Mat - Grime - Small / (L) Front Floor Mat - Grime - Small / (L) Front Floor Mat - Worked - Small / (L) Front Seat - Grime - Small / (R) Front Seat - Grime - Small / (L) Front Trim - Grime - Medium / (R) Front Trim - Grime - Medium</p>	<p>Remarks (L) Side Gate - Scratch & Dent - Small / Rear Bumper, Lamps, Panels - Rust, Corrosion - Medium / Rear Gate - Scratch - Medium / (R) Side Gate - Scratch & Dent - Small / (R) Center Panel - Scratch & Dent - Small / (R) Front Door, Molding - Scratch & Dent - Small / (R) Front Fender, Molding - Scratch - Small / Front Panel - Scratch - Small / (L) Front Fender, Molding - Scratch & Dent - Medium / (L) Front Door, Molding - Scratch & Dent - Medium / (L) Center Panel - Scratch - Small / Roof - Scratch & Dent - Small / Front Bumper, Grille, Lamps - Scratch & Dent - Medium</p>
