General Information

Make	Mitsubishi	Model	Mirage
YOM	2024	Odo Meter Reading	7,732
Registration No.	DBQ3526	Chassis No.	PAEA13MJRRA018787
CC	1.2	Transmission	M/T
Fuel Type	Gas	Type of Body	Sedan
Colour	Gray

Body / Panel Condition

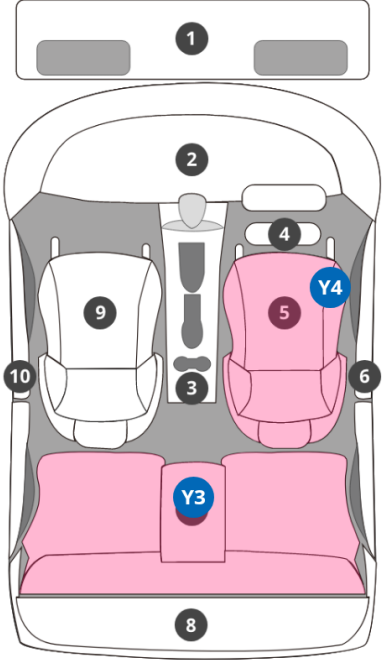
<p>a : Cut, Fray d : Loose, Deformed k : Animal Hair s : Smell t : Cigarette Burns x : Defective y : Stain</p>

<p>A : Scratch AU : Scratch & Dent B : Modified C : Corrosion G : Stone chip P : Faded S : Rust SC : Rust & Corrosion U : Dent X : Defective Y : Crack, Gap</p>
<p>Remarks Rear Seat - Grime - Medium / (R) Front Seat - Grime - Large</p>	<p>Remarks Front Bumper, Grille, Lamps - Crack, Gap - Large / (L) Front Fender, Molding - Scratch - Large / (L) Front Door, Molding - Scratch - Large / (L) Rear Door, Molding - Scratch - Large / (R) Rear Door, Molding - Dent - Small / (R) Rear Fender, Molding - Scratch - Small / (L) Rear Fender, Molding - Scratch & Dent - Small / (R) Front Door, Molding - Scratch - Minimal / (R) Front Fender, Molding - Scratch - Minimal</p>
Frame Evaluation : A	Functional Evaluation : A
<p>Remarks Defects not found</p>	<p>Remarks Reverse Camera - N/A - Yes / Spare Key - Issue - Unexist</p>
