General Information

Make	Toyota	Model	Vios
YOM	2025	Odo Meter Reading	9,817
Registration No.	DBS9134	Chassis No.	PA1B18F36S4281890
CC	1.3	Transmission	CVT
Fuel Type	Gas	Type of Body	Sedan
Colour	Red

Body / Panel Condition

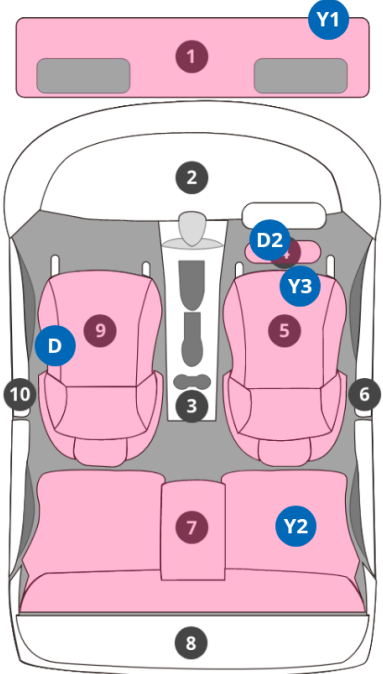
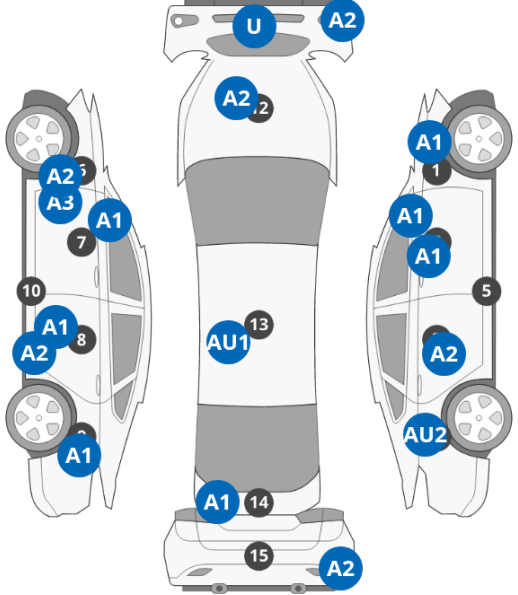
Interior Evaluation :	B	Exterior Evaluation :	C

<p>a : Cut, Fray d : Loose, Deformed k : Animal Hair s : Smell t : Cigarette Burns x : Defective y : Stain</p>		<p>A : Scratch AU : Scratch & Dent B : Modified C : Corrosion G : Stone chip P : Faded S : Rust SC : Rust & Corrosion U : Dent X : Defective Y : Crack, Gap</p>	
<p>Remarks (R) Front Seat - Grime - Medium / (L) Front Seat - Worn - Yes / (L) Front Floor Mat - Worked - Small / Ceiling - Grime - Minimal / Rear Seat - Grime - Small</p>		<p>Remarks (R) Front Fender, Molding - Scratch - Minimal / (R) Mirror - Scratch - Minimal / (R) Front Door, Molding - Scratch - Minimal / (R) Rear Door, Molding - Scratch - Small / (R) Rear Fender, Molding - Scratch & Dent - Small / Rear Bumper, Lamps, Panels - Scratch - Small / Trunk Hood, Rear Gate - Scratch - Minimal / (L) Rear Fender, Molding - Scratch - Minimal / (L) Step, In-panel, Side Spoiler - Scratch - Small / (L) Rear Door, Molding - Scratch - Minimal / (L) Front Door, Molding - Scratch - Medium / Member (Bolted) - Dent - Yes / (L) Front Fender, Molding - Scratch - Small / (L) Mirror - Scratch - Minimal / Bonnet, Headlight - Scratch - Small / Front Bumper, Grille, Lamps - Scratch - Small / Roof - Scratch & Dent - Minimal</p>

Inspector Notes
no warranty booklet, with jack, no tools, with spare tire, with LTO plate, scratches on tail light
