General Information

Make	Mitsubishi	Model	Strada
YOM	2023	Odo Meter Reading	34,196
Registration No.	LAL7716	Chassis No.	MMBJKL10PH048738
CC	2.4	Transmission	M/T
Fuel Type	Diesel	Type of Body	Pickup
Colour	Gray

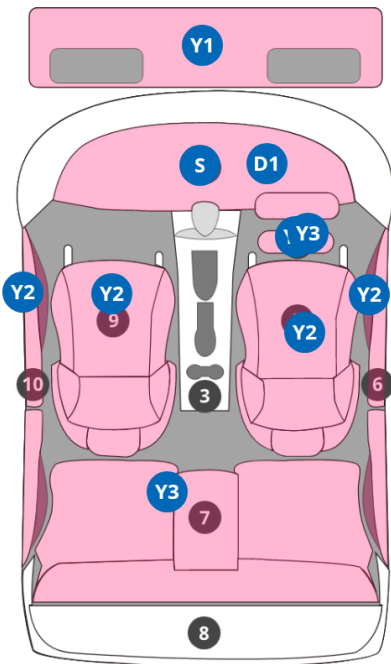
Interior Evaluation : C	Exterior Evaluation : E

<p>a : Cut, Fray d : Loose, Deformed k : Animal Hair s : Smell t : Cigarette Burns x : Defective y : Stain</p>

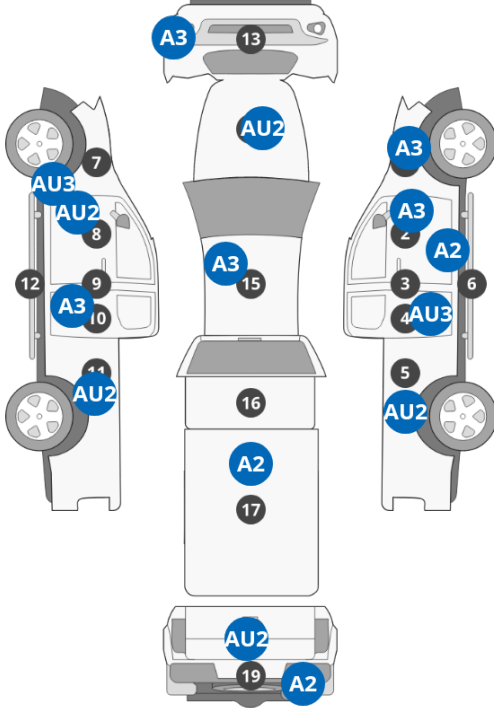
<p>A : Scratch AU : Scratch & Dent B : Modified C : Corrosion G : Stone chip P : Faded S : Rust SC : Rust & Corrosion U : Dent X : Defective Y : Crack, Gap</p>
<p>Remarks (L) Front Trim - Grime - Small / (R) Front Trim - Grime - Small / (L) Front Seat - Grime - Small / (R) Front Seat - Grime - Small / Overall Interior - Smell - Yes / Dashboard - Worked - Minimal / (L) Front Floor Mat - Grime - Medium / (R) Front Floor Mat - Grime - Medium / Rear Seat - Grime - Medium / Ceiling - Grime - Minimal</p>	<p>Remarks Bonnet, Headlight - Scratch & Dent - Small / Front Bumper, Grille, Lamps - Scratch - Medium / (L) Front Fender, Molding - Scratch & Dent - Medium / (L) Front Door, Molding - Scratch & Dent - Small / (L) Rear Door, Molding - Scratch - Medium / (L) Side Gate - Scratch & Dent - Small / Rear Gate - Scratch & Dent - Small / Rear Bumper, Lamps, Panels - Scratch - Small / (R) Side Gate - Scratch & Dent - Small / (R) Rear Door, Molding - Scratch & Dent - Medium / (R) Step, In-panel, Side Spoiler - Scratch - Small / (R) Front Door, Molding - Scratch - Medium / (R) Front Fender, Molding - Scratch - Medium / Roof - Scratch - Medium / Cargo Bed Floor - Scratch - Small</p>
