General Information

Make	Toyota	Model	Vios
YOM	2025	Odo Meter Reading	9,559
Registration No.	NHS7507	Chassis No.	PA1B18F3XR4265721
CC	1.3	Transmission	CVT
Fuel Type	Gas	Type of Body	Sedan
Colour	Blue

Body / Panel Condition

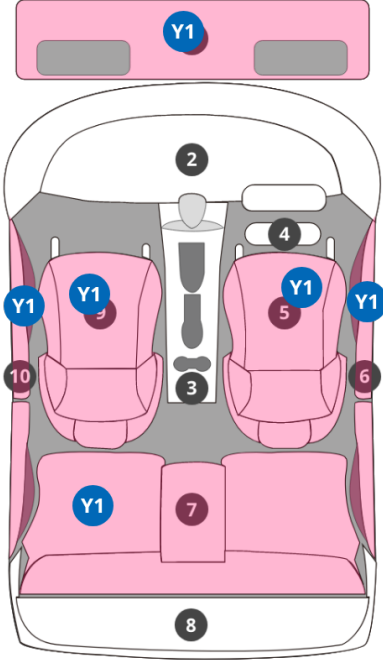
Interior Evaluation : A	Exterior Evaluation : C

<p>a : Cut, Fray d : Loose, Deformed k : Animal Hair s : Smell t : Cigarette Burns x : Defective y : Stain</p>

<p>A : Scratch AU : Scratch & Dent B : Modified C : Corrosion G : Stone chip P : Faded S : Rust SC : Rust & Corrosion U : Dent X : Defective Y : Crack, Gap</p>
<p>Remarks Rear Seat - Grime - Minimal / (L) Front Seat - Grime - Minimal / (R) Front Seat - Grime - Minimal / (L) Front Trim - Grime - Minimal / (R) Front Trim - Grime - Minimal / Ceiling - Grime - Minimal</p>	<p>Remarks (L) Rear Fender, Molding - Scratch - Small / Trunk Hood, Rear Gate - Scratch & Dent - Minimal / Rear Bumper, Lamps, Panels - Scratch - Medium / (R) Rear Fender, Molding - Scratch & Dent - Minimal / Roof - Scratch - Medium / (R) Rear Door, Molding - Scratch - Small / (R) Front Door, Molding - Scratch - Small / (L) Rear Door, Molding - Scratch & Dent - Small / (L) Front Door, Molding - Scratch & Dent - Small / (L) Front Fender, Molding - Scratch & Dent - Small / Bonnet, Headlight - Scratch & Dent - Small / Front Bumper, Grille, Lamps - Scratch & Dent - Small / (R) Front Fender, Molding - Scratch & Dent - Small / (R) Step, In-panel, Side Spoiler - Scratch & Dent - Small</p>
