General Information

Make	Hyundai	Model	Stargazer
YOM	2023	Odo Meter Reading	45,611
Registration No.	NIO2476	Chassis No.	MF3NB81DEPJ017117
CC	1.5	Transmission	A/T
Fuel Type	Gas	Type of Body	MPV
Colour	Silver

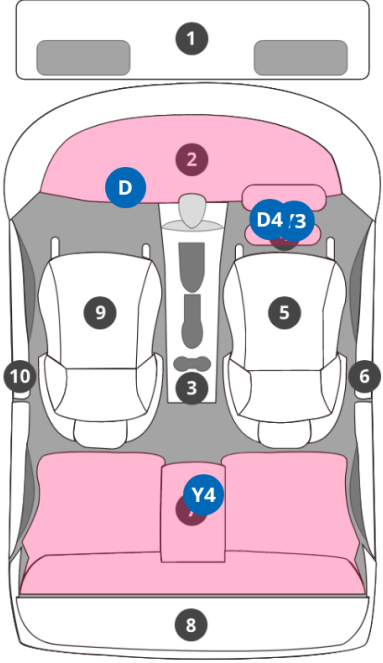
Interior Evaluation : C	Exterior Evaluation : E

<p>a : Cut, Fray d : Loose, Deformed k : Animal Hair s : Smell t : Cigarette Burns x : Defective y : Stain</p>

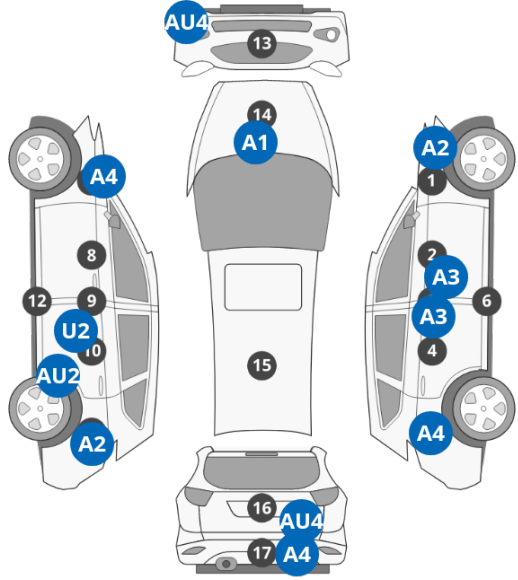
<p>A : Scratch AU : Scratch & Dent B : Modified C : Corrosion G : Stone chip P : Faded S : Rust SC : Rust & Corrosion U : Dent X : Defective Y : Crack, Gap</p>
<p>Remarks Rear Seat - Grime - Large / Dashboard - Traces of Adhesive Tape - Yes / (R) Front Floor Mat - Grime - Medium / (L) Front Floor Mat - Worked - Large</p>	<p>Remarks Front Bumper, Grille, Lamps - Scratch & Dent - Large / (L) Front Fender, Molding - Scratch - Large / (L) Rear Door, Molding - Dent - Small / (L) Step, In-panel, Side Spoiler - Scratch & Dent - Small / Trunk Hood, Rear Gate - Scratch & Dent - Large / Rear Bumper, Lamps, Panels - Scratch - Large / (R) Front Door, Molding - Scratch - Medium / (R) Rear Door, Molding - Scratch - Medium / (R) Rear Fender, Molding - Scratch - Large / (R) Front Fender, Molding - Scratch - Small / (L) Rear Fender, Molding - Scratch - Small / Bonnet, Headlight - Scratch - Minimal</p>
