General Information

Make	Jetour	Model	Dashing
YOM	2024	Odo Meter Reading	8,586
Registration No.	NKH7486	Chassis No.	HJRPBGFB7RB159296
CC	1.5	Transmission	A/T
Fuel Type	Gas	Type of Body	SUV
Colour	Gray

Body / Panel Condition

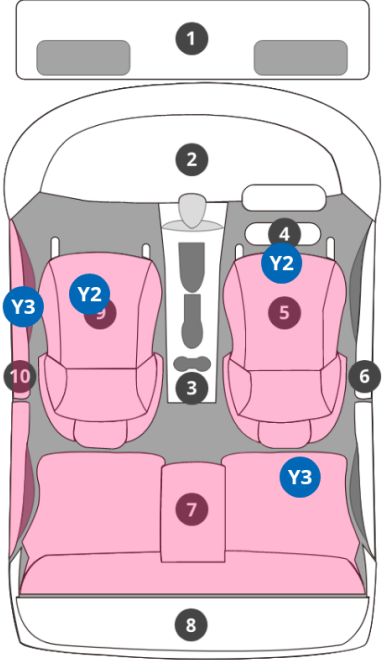
<p>a : Cut, Fray d : Loose, Deformed k : Animal Hair s : Smell t : Cigarette Burns x : Defective y : Stain</p>

<p>A : Scratch AU : Scratch & Dent B : Modified C : Corrosion G : Stone chip P : Faded S : Rust SC : Rust & Corrosion U : Dent X : Defective Y : Crack, Gap</p>
<p>Remarks (L) Front Trim - Grime - Medium / Rear Seat - Grime - Medium / (R) Front Seat - Grime - Small / (L) Front Seat - Grime - Small</p>	<p>Remarks (R) Front Fender, Molding - Scratch - Medium / Rear Bumper, Lamps, Panels - Scratch & Dent - Large / (L) Front Door, Molding - Dent - Small / Front Bumper, Grille, Lamps - Scratch - Small</p>
Frame Evaluation : A	Functional Evaluation : A
<p>Remarks Defects not found</p>	<p>Remarks Defects not found</p>
