## General Information

| Make | Toyota | Model | Avanza |

## Body / Panel Condition

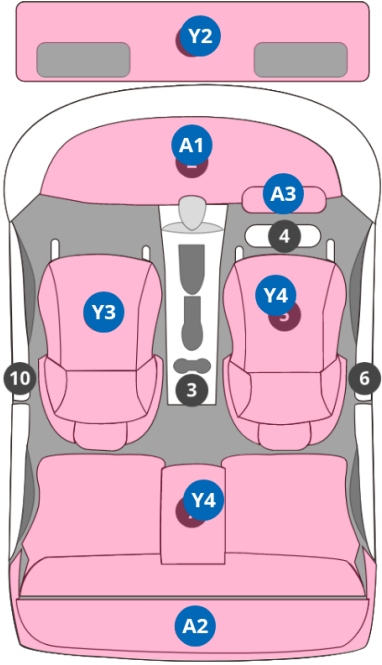
| Interior Evaluation : <span style="color: red;">C</span> | Exterior Evaluation : <span style="color: red;">E</span> |
|---|---|
| <b>Remarks</b><br>Rear Seat - Grime - Large / (R) Front Seat - Grime - Large / Trunk Room - Worn, Scratch, Cut, Crack - Small / (L) Front Seat - Grime - Medium / Steering Wheel - Worn, Peel, Crack - Medium / Ceiling - Grime - Small / Dashboard - Worn, Scratch, Cut, Crack - Minimal | <b>Remarks</b><br>(L) Mirror - Crack - Damaged / (R) Mirror - Crack - Damaged / Front Bumper, Grille, Lamps - Scratch - Large / (L) Front Fender, Molding - Scratch - Small / (L) Front Door, Molding - Scratch - Small / (L) Step, In-panel, Side Spoiler - Scratch - Small / (L) Rear Door, Molding - Scratch - Medium / (L) Rear Fender, Molding - Scratch & Dent - Small / Rear Bumper, Lamps, Panels - Scratch - Small / Trunk Hood, Rear Gate - Scratch - Small / (R) Rear Fender, Molding - Scratch - Small / (R) Rear Door, Molding - Scratch - Medium / (R) Front Door, Molding - Scratch - Small / (R) Front Fender, Molding - Scratch - Small / Roof - Scratch & Dent - Small / Bonnet, Headlight - Scratch & Dent - Small |
