## General Information

| Make | Toyota | Model | Vios |
| Registration No. | DBU5767 | Chassis No. | PA1B18F37S4288248 |

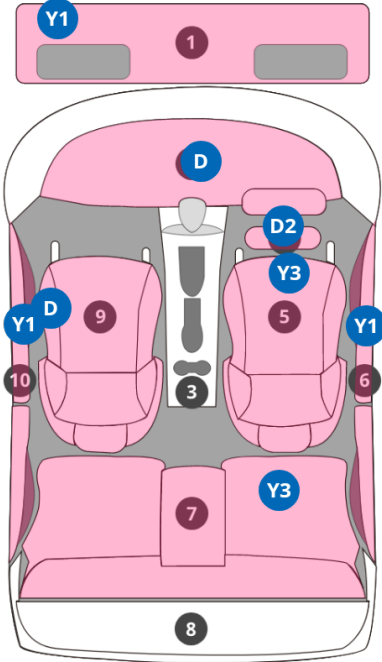
| Interior Evaluation : <b>B</b> | Exterior Evaluation : <b>B</b> |
|---|---|
| <p><b>Remarks</b><br/>(L) Front Seat - Worn - Yes / (R) Front Seat - Grime - Medium / (R) Front Trim - Grime - Minimal / (L) Front Trim - Grime - Minimal / Dashboard - Traces of Adhesive Tape - Yes / Ceiling - Grime - Minimal / Rear Seat - Grime - Medium / (L) Front Floor Mat - Worked - Small</p> | <p><b>Remarks</b><br/>(L) Front Fender - Repair Traces - Yes / (R) Mirror - Scratch - Minimal / (R) Front Fender, Molding - Scratch - Minimal / (R) Rear Door, Molding - Scratch - Small / (R) Front Door, Molding - Scratch - Minimal / (R) Rear Fender, Molding - Scratch - Minimal / Member (Bolted) - Dent - Yes / Rear Bumper, Lamps, Panels - Scratch - Small / Trunk Hood, Rear Gate - Scratch - Minimal / (L) Rear Fender, Molding - Scratch - Minimal / (L) Rear Door, Molding - Scratch - Minimal / (L) Front Door, Molding - Scratch - Minimal / (L) Mirror - Scratch - Minimal / (L) Front Fender, Molding - Scratch - Minimal / Front Bumper, Grille, Lamps - Scratch - Small / Bonnet, Headlight - Scratch - Minimal / Roof - Scratch - Minimal</p> |

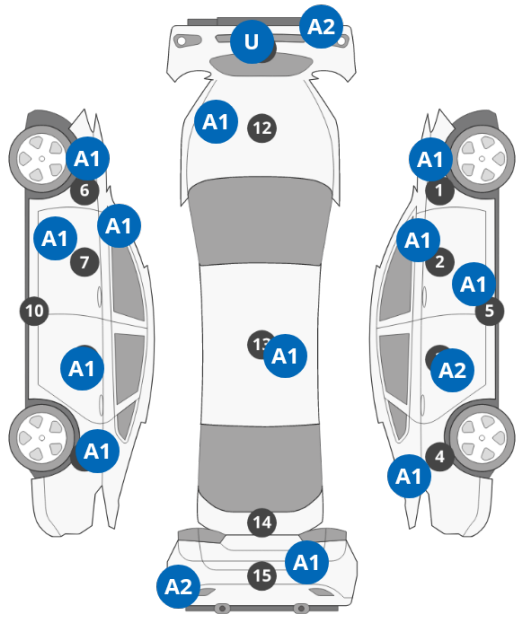
| Inspector Notes |
|---|
| with warranty booklet, with jack and tools, with spare tire, with LTO plate, scratches on tail light |
