## General Information

| Make | Toyota | Model | Raize |
| YOM | 2023 | Odo Meter Reading | 24,977 |
| Registration No. | EAG5055 | Chassis No. | MHKAB1BA7PJ051726 |

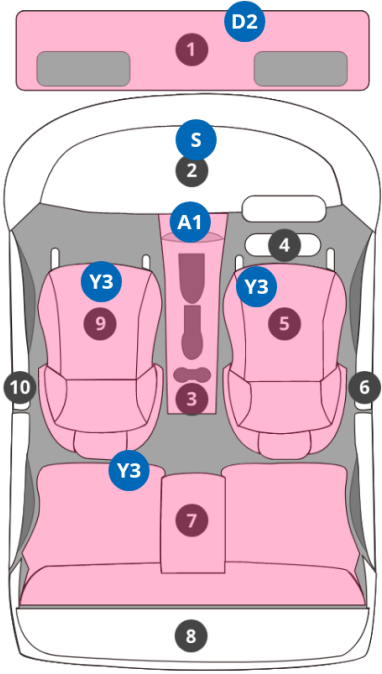
| Interior Evaluation : <b>B</b> | Exterior Evaluation : <b>C</b> |
| <b>Remarks</b><br>Overall Interior - Smell - Yes / (L) Front Seat - Grime - Medium / (R) Front Seat - Grime - Medium / Rear Seat - Grime - Medium / Ceiling - Crinkle - Small / Console, Switchs, Vents - Worn, Scratch, Cut, Crack - Minimal | <b>Remarks</b><br>(R) Front Fender, Molding - Scratch - Minimal / (R) Mirror - Scratch - Small / (R) Front Door, Molding - Scratch - Small / (R) Rear Door, Molding - Scratch - Small / (R) Rear Fender, Molding - Scratch - Minimal / Rear Bumper, Lamps, Panels - Scratch - Small / Trunk Hood, Rear Gate - Scratch - Small / (L) Rear Fender, Molding - Scratch - Minimal / (L) Step, In-panel, Side Spoiler - Scratch - Minimal / (L) Rear Door, Molding - Scratch - Minimal / (L) Front Door, Molding - Scratch & Dent - Small / (L) Mirror - Scratch - Small / (L) Front Fender, Molding - Scratch - Minimal / Front Bumper, Grille, Lamps - Scratch - Medium / Bonnet, Headlight - Scratch - Minimal / Roof - Scratch - Small |

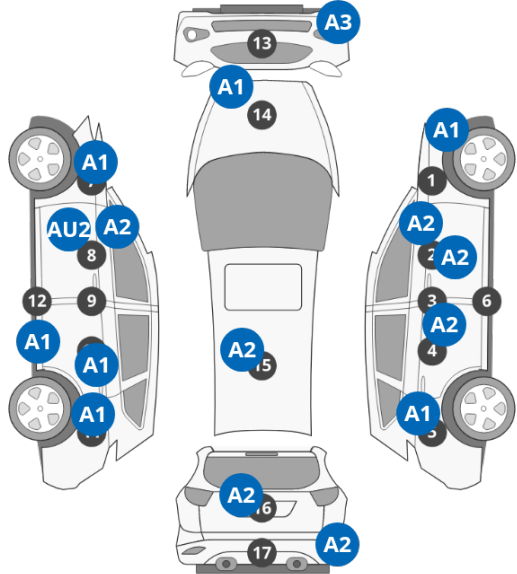
| Inspector Notes |
|---|
| no warranty booklet and tools, with jack, with spare tire, with LTO plate, scratches on tail light, daytime running light issue |
